**GEOLOGY OF TASIK PERGAU JELI,  
KELANTAN AND ROCK SLOPE MASS RATING  
ALONG GERIK-JELI HIGHWAY**

A thesis submitted in fulfilment of the requirements for the degree of  
Bachelor of Applied Science (Geosciences) with Honours

**FACULTY OF EARTH SCIENCE**

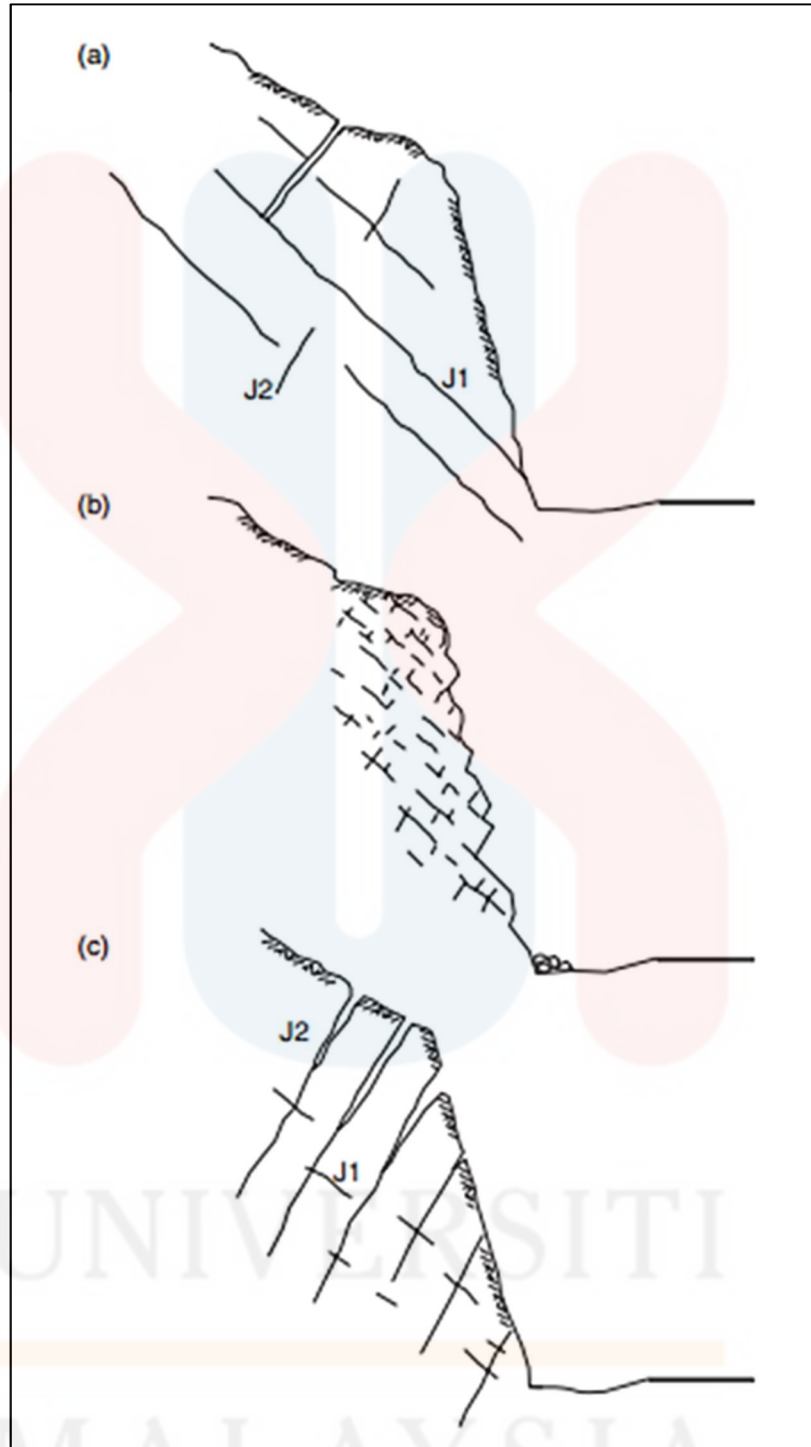
**Figure 2.3:** Effect of joint on the stability of slope (Wyllie & Mah, 2004).

The persistence, spacing, infilling and roughness are significant factors influencing the stability of the slope. The orientation is the prime geological factor that controls the stability of the slope. The Figure 2.3 represents three slopes excavated in a rock mass containing joint set J1 and joint set J2. J1 dips about  $45^\circ$  out the face whereas J2 dips into the face at about  $60^\circ$ . In Figure 2.3(a), the plane failure is probably to occur due to the greater persistence of J1 than the slope height and widely spaced of J1. Both J1 and J2 of slope at Figure 2.3(b) are closely spaced and have low persistent. Therefore, the slope is considered stable. In Figure 2.3(c), toppling failure may exist because J2 is persistent and closely spaced, forming series thin slabs dipping into the face (Wyllie & Mah, 2004).

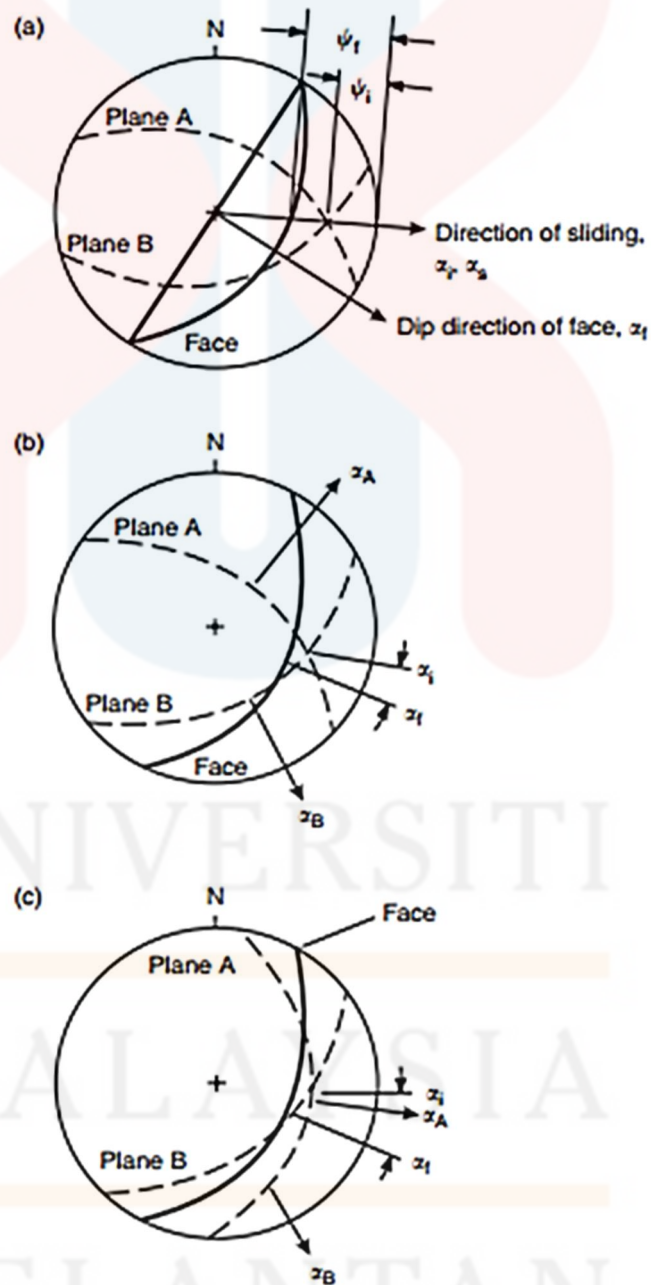
Figure 2.5: Identification of plane and wedge failure on stereonet (Wyllie & Mah, 2004).

In Figure 2.5(a), the plane and wedge failure may occur when the dip of sliding plane for the case of plane failure or the plunge of intersection of plane for the case of wedge failure, be less than the dip of the slope face. ( $\psi_i < \psi_f$ ). That is, the sliding surface “daylight” in the slope face. The test can also differentiate between sliding of wedge on two planes along the line of intersection, or along only one of the planes

such that a plane failure occur. In Figure 2.5(b), the wedge will slide on both planes if the dip directions of the two planes lie outside the included angle between  $\alpha_i$  (trend of intersection line) and  $\alpha_f$  (dip direction of face). If the dip direction of one plane A as shown in Figure 2.5(c) lies within the included angle between  $\alpha_i$  and  $\alpha_f$ , the wedge will slide on only that plane.

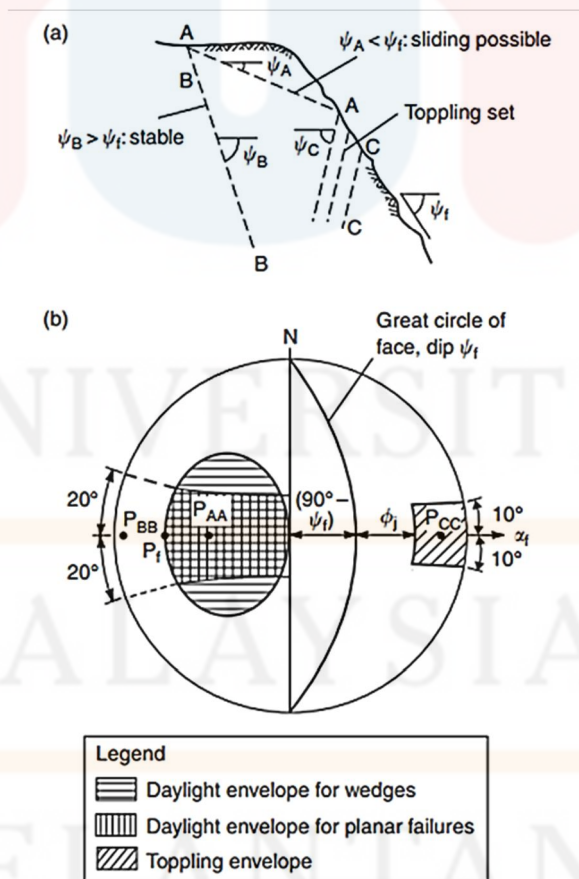
**Figure 2.6:** Kinematic analysis of blocks of rock in slope: (a) Discontinuity set in slope; (b) daylight envelope on equal area stereonet (Wyllie & Mah, 2004).

In Figure 2.6, the planar block is potentially unstable because plane AA dips gentler angle than the slope face ( $\psi_A < \psi_f$ ) which means plane AA daylight on the face. Plane BB dips steeper than the dip of slope face and does not daylight ( $\psi_B > \psi_f$ ). Thus, sliding is not possible on plane BB. Plane CC dips into the face and sliding is impossible to occur on these plane, even though toppling failure is possible. The poles of discontinuities sets and the pole of slope face are plotted on the stereonet. The slope is potentially unstable when the poles of the plane lie inside the pole of slope face or termed daylight envelope. The stability of the slope is also influenced by the dip direction of the discontinuity set. If the dip direction of the discontinuity differs from the dip direction of face by more than about  $20^\circ$ , the plane sliding is not possible. The block will be stable if  $|\alpha_A - \alpha_f| > 20^\circ$  because under these condition, thickness of intact rock will increase at one end of the block which will have sufficient strength to resist failure. On stereonet, this restriction on the dip direction of the planes is shown by two lines defining dip direction of  $(\alpha_f + 20^\circ)$  and  $(\alpha_f - 20^\circ)$ . These two lines designate the lateral limits of the daylight envelope on Figure 2.5(b).

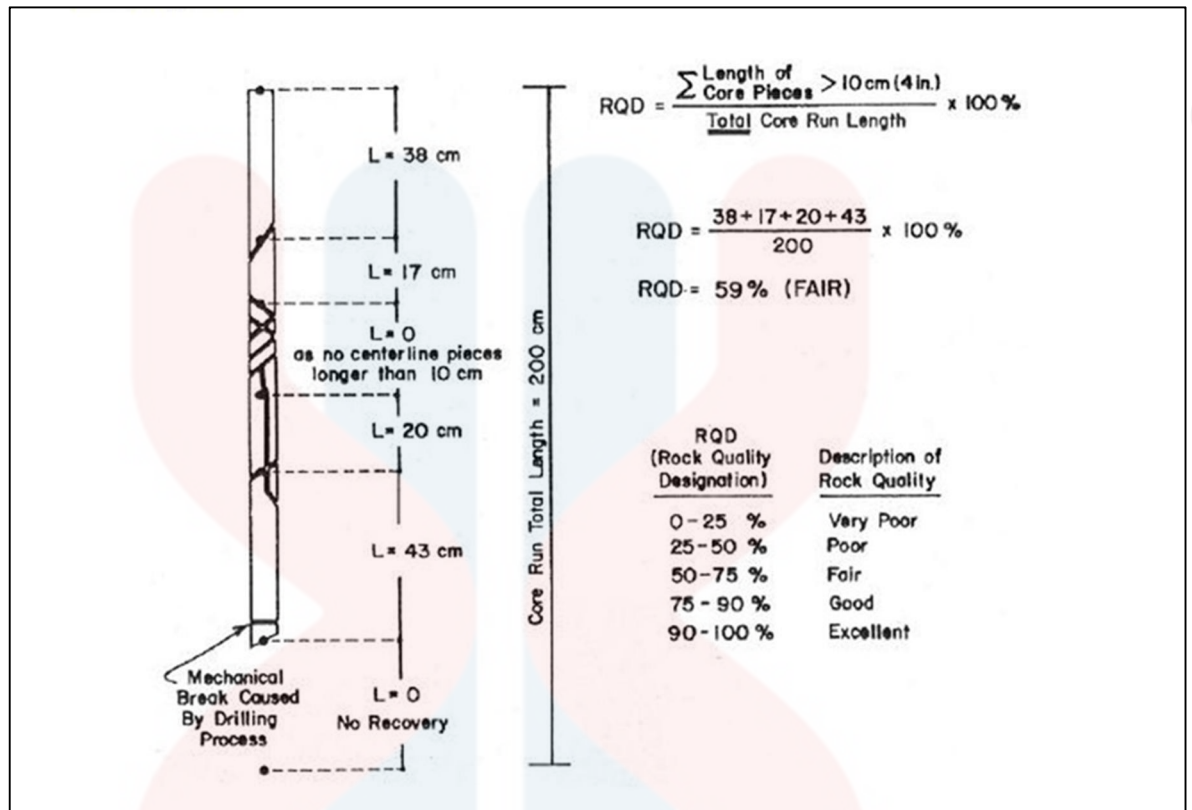
Figure 2.8: Procedure for measurement and calculation of rock quality designation (Deere & Deere, 1988)

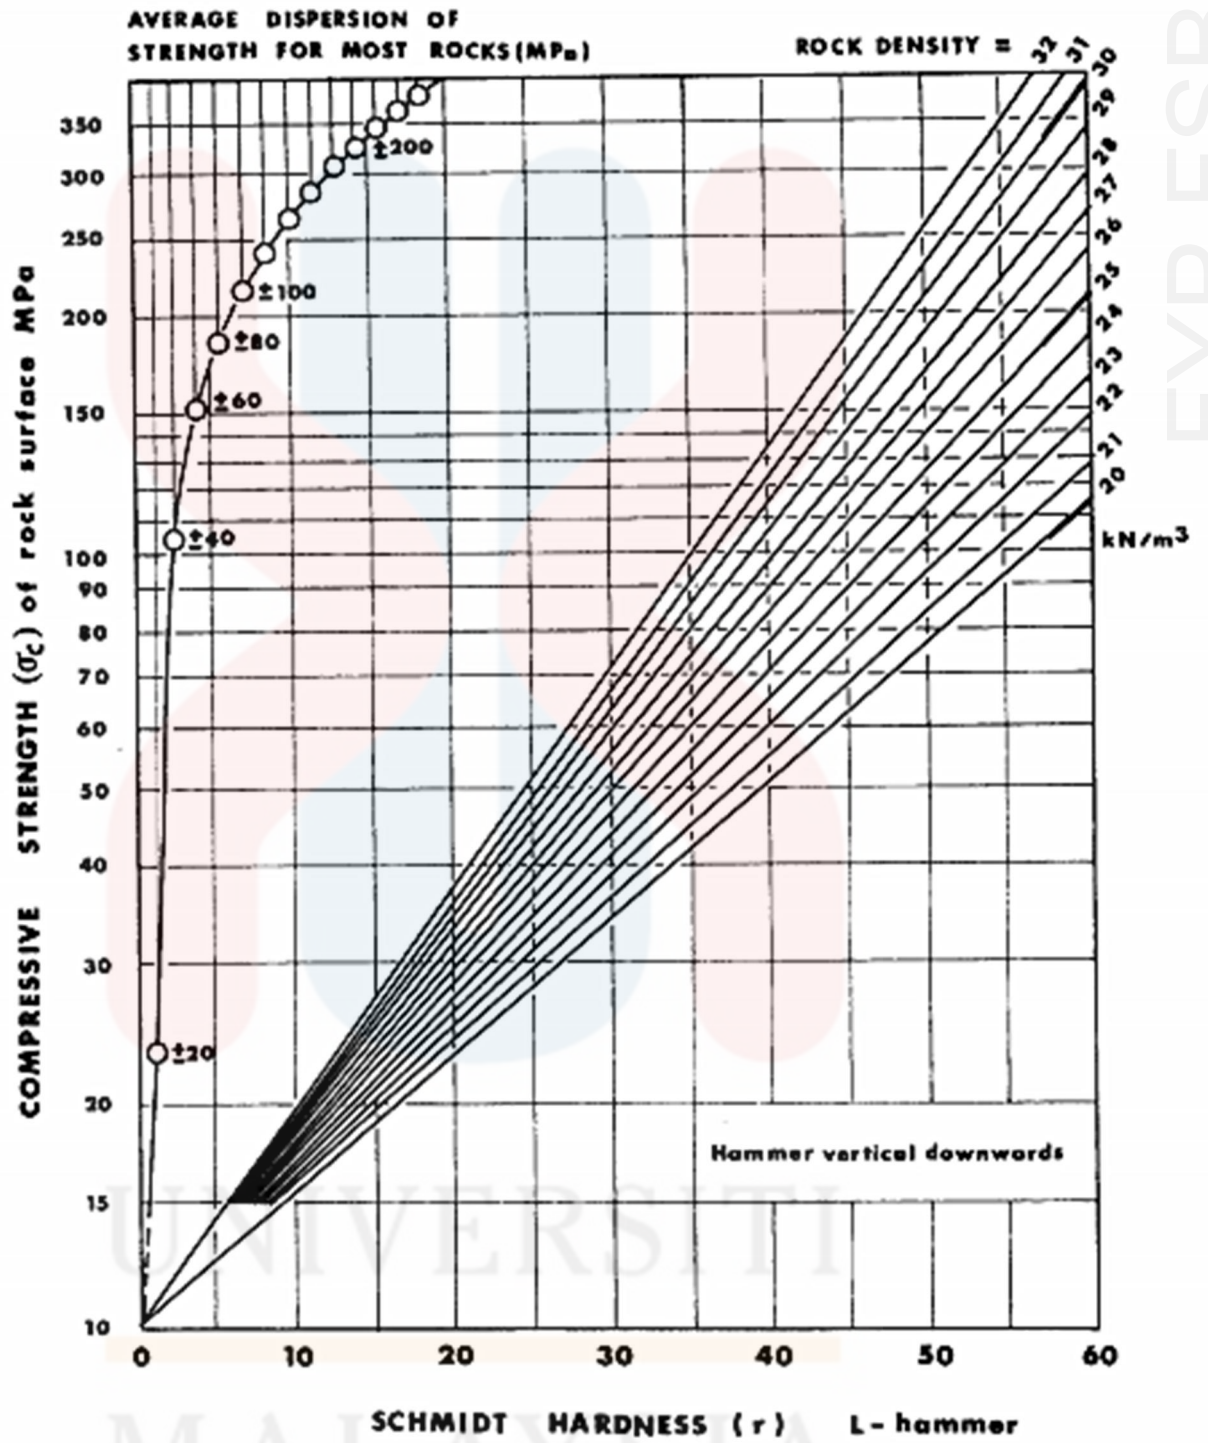
Figure 2.9: Correlation chart for Schmidt hammer, relating rock density, compressive strength and rebound number (ISRM, 1978)

The uniaxial compressive strength can be tested in the field or laboratory. Schmidt hammer rebound test is one of the field test that can be used to determine the uniaxial compressive strength. The test can be performed on the surface of rock materials obtained from freshly broken rock. In practice, the rebound number from Schmidt hammer test ranged from 10 to 60. The lowest number of rebound means the rock is the weakest and has lowest compressive strength where  $\sigma_c \leq 20$ MPa. The highest rebound number indicates that the rock is strong and has highest uniaxial compressive strength where  $\sigma_c \geq 150$ MPa. When the rebound number and rock density are obtained, the correlation can be made with correlation chart suggested by ISRM (1978) in Figure 2.9. The rebound number depends on the direction of Schmidt hammer applied on wall of rock mass. The rebound number is minimum when the hammer applied vertically downwards to the surface of rock. The rebound number is maximum when it is vertically upwards. Therefore, the correction is made based on the table shown in Table 2.3 (ISRM, 1978).

The  $R_{true}$  value can be correlated with the chart introduced by ISRM (1978) as shown in Figure 2.9 to get the UCS value.

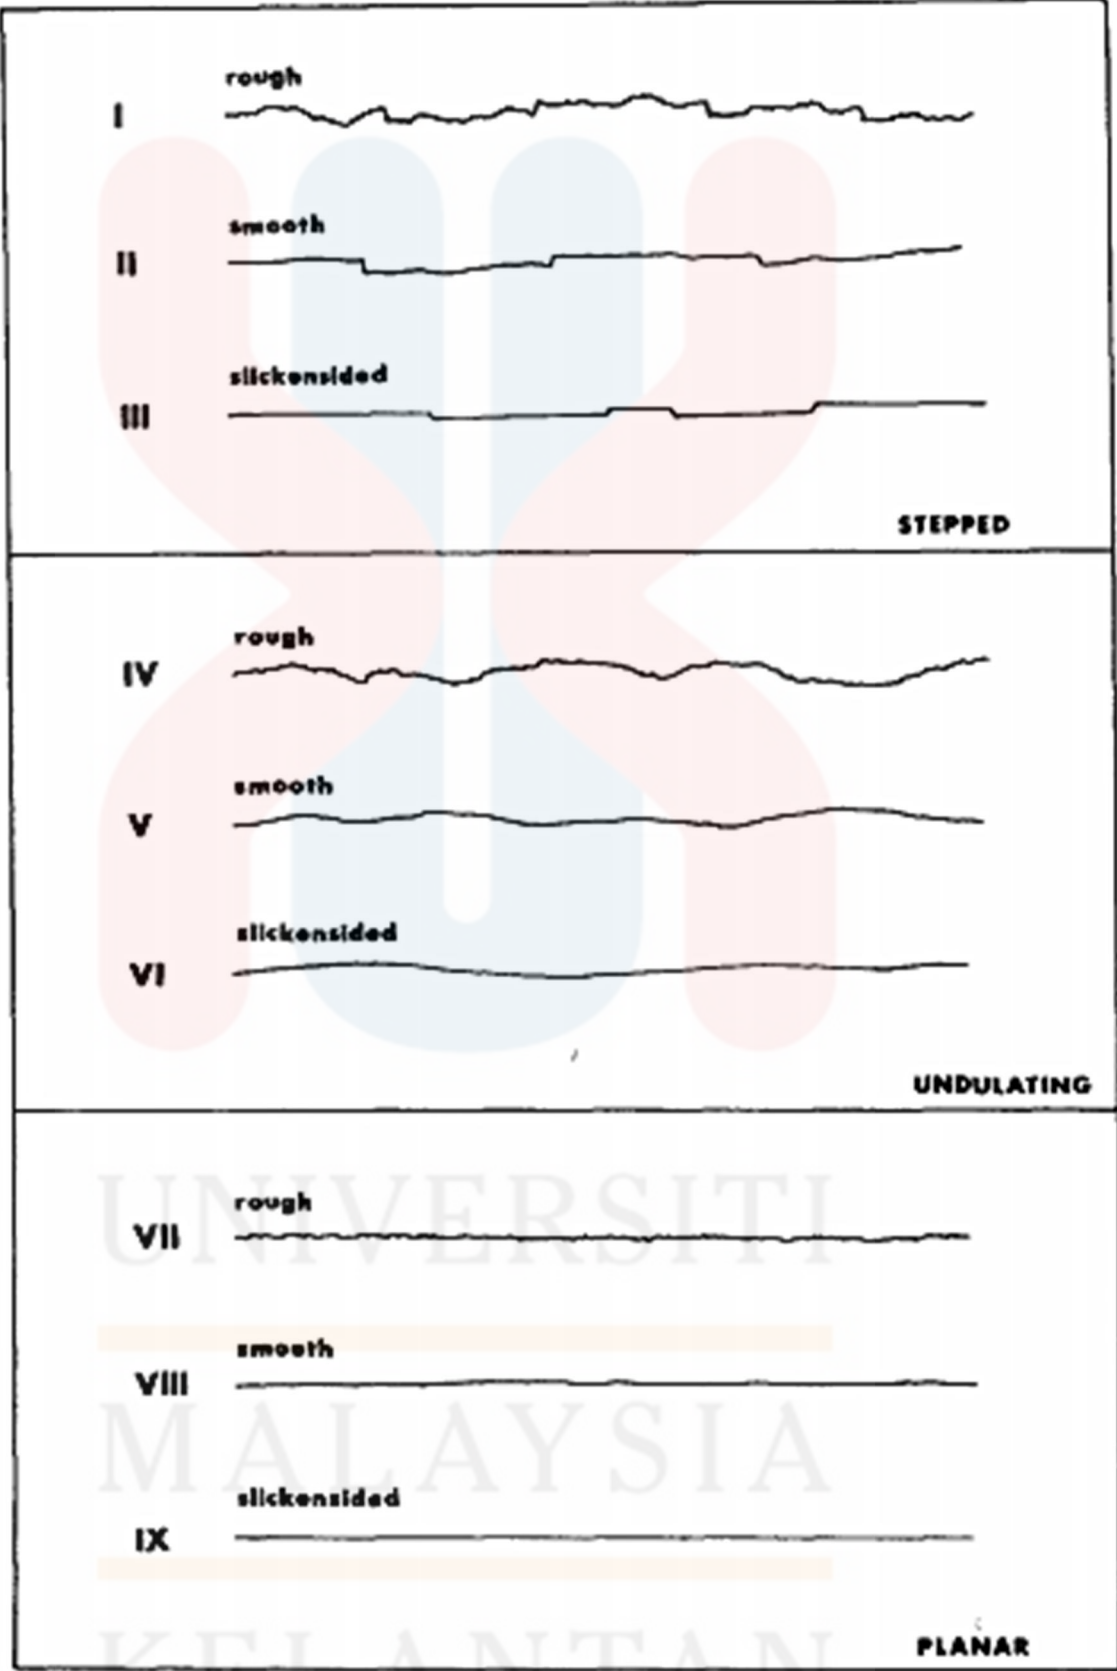
Figure 2.10: Roughness profile and suggested nomenclature (ISRM, 1978)

- (a) Roughness is an important parameter in controlling the shear strength of rock discontinuities. Surface roughness of discontinuity can be characterized by waviness and unevenness. Waviness is a large scale of undulations, which tends to cause dilation during shear displacement whereas unevenness is a small scale of roughness that tends to be damaged during displacement unless the discontinuity wall is high in strength. A simple and time-saving method to evaluate the roughness of the surface is by evaluating through the roughness profile provided by ISRM (1978) as shown in Figure 2.10

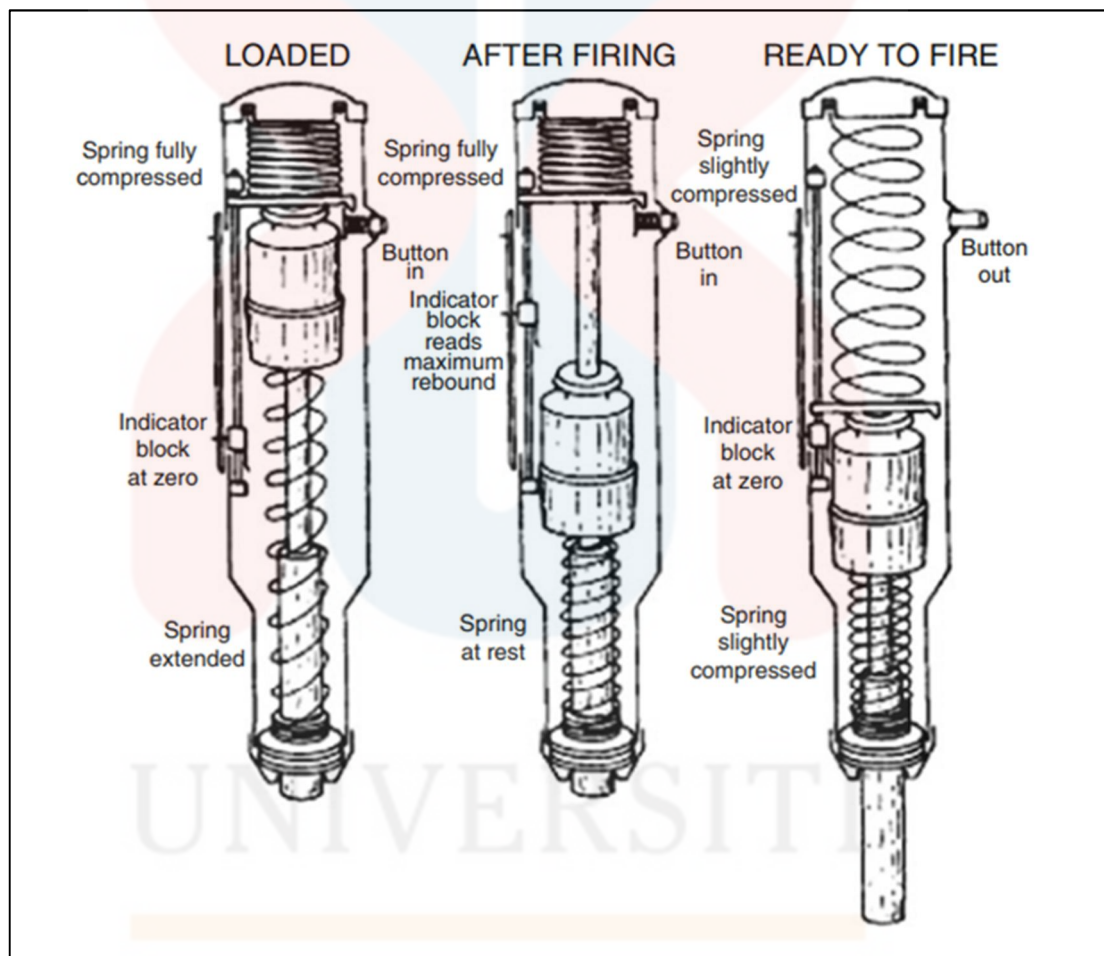
**Figure 3.8:** Operational principal of Schmidt hammer (Aydin, 2015)

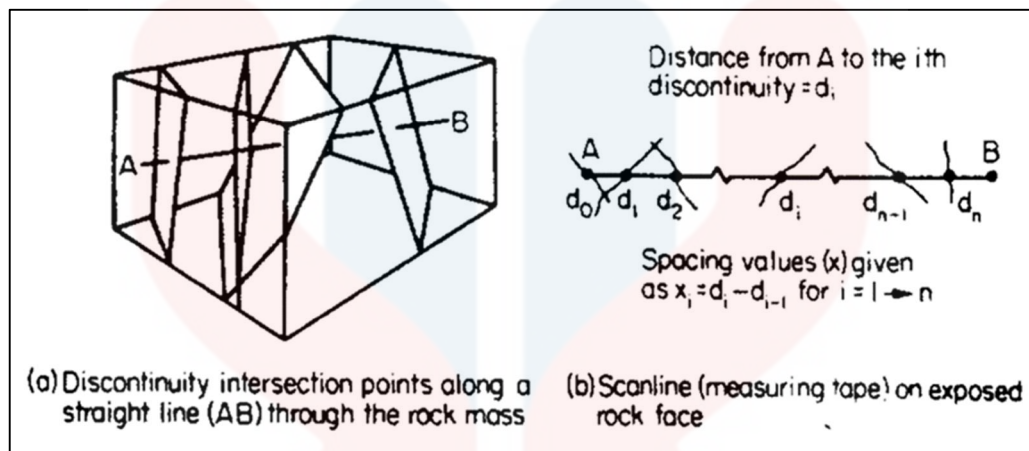
Figure 3.9: Measurement of spacing discontinuities (Priest & Hudson, 1976)

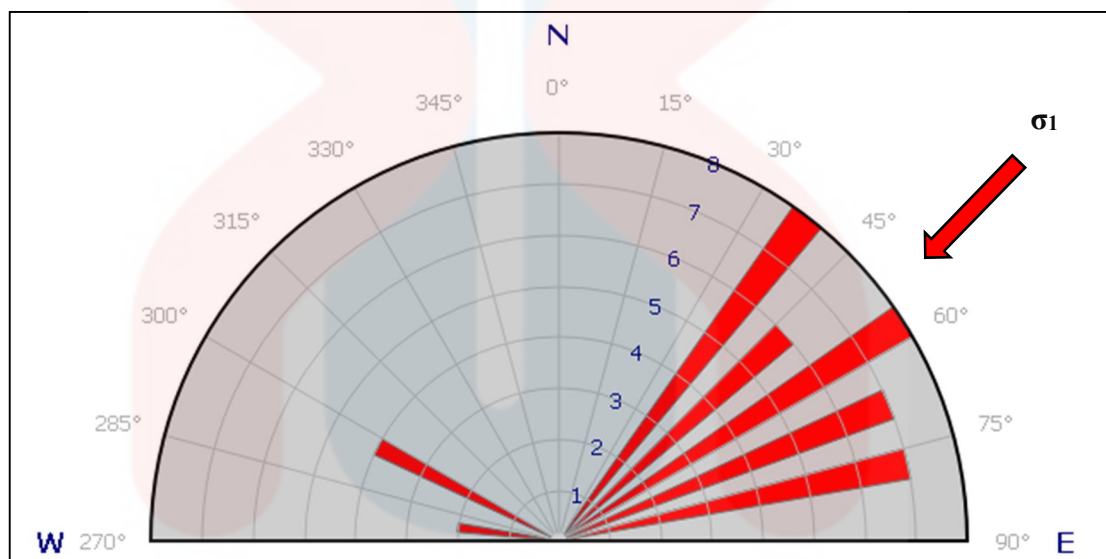
**Figure 4.4.5:** Rose diagram for the orientation of discontinuities collected from the study area

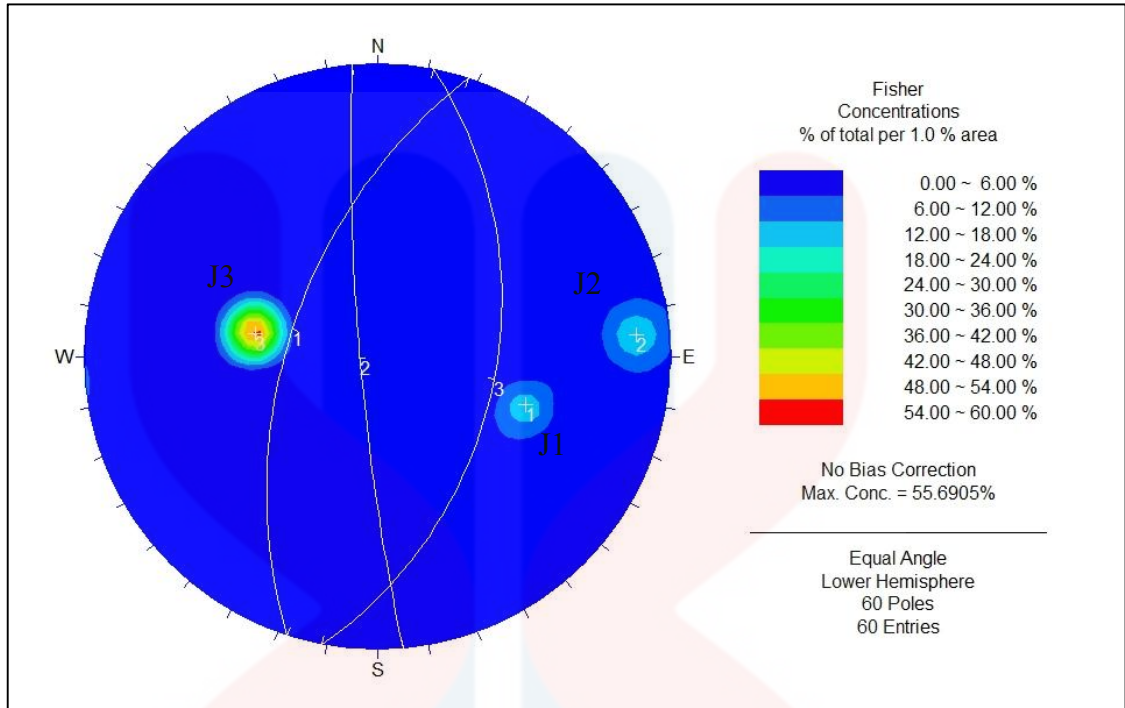
Figure 5.2.1: Contour plot of orientation of joints on Slope 1

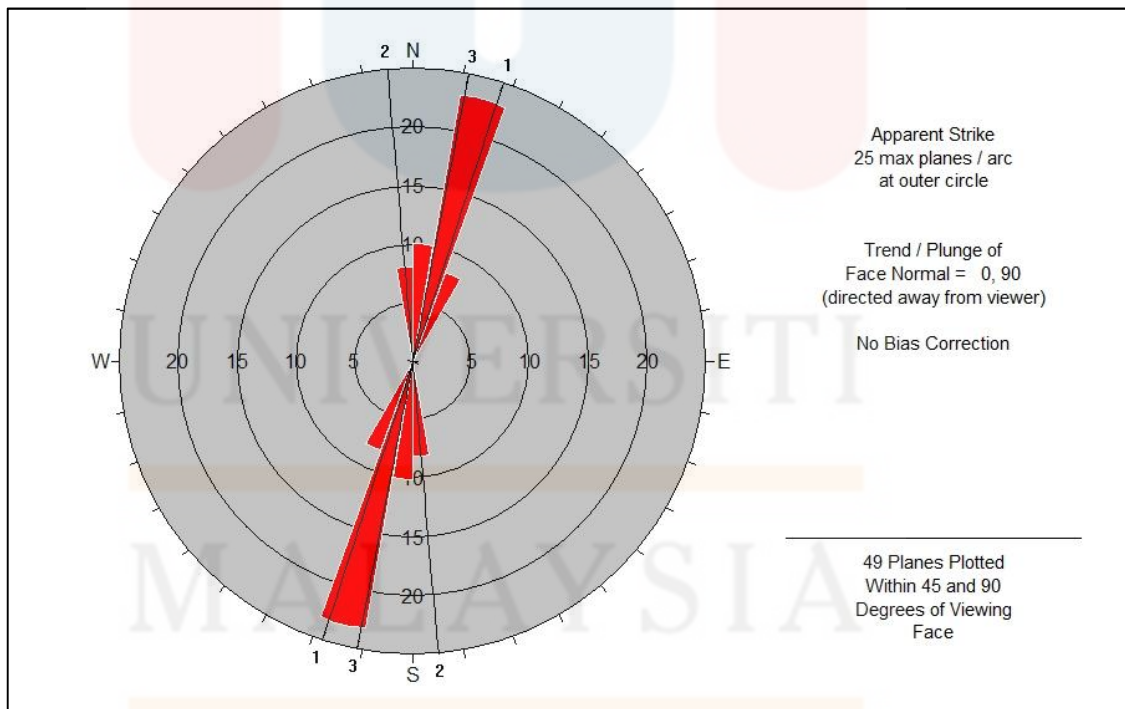
Figure 5.2.2: Rosette plot of orientation of joints on Slope 1

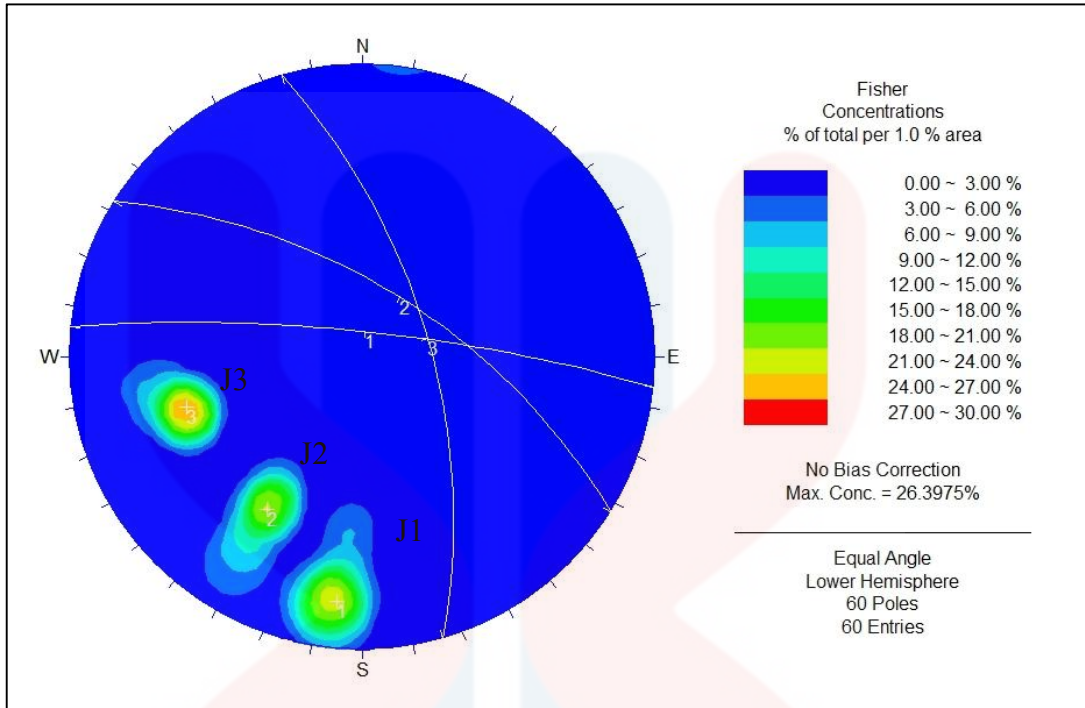
Figure 5.2.5: Contour plot of orientation of joints on Slope 3A

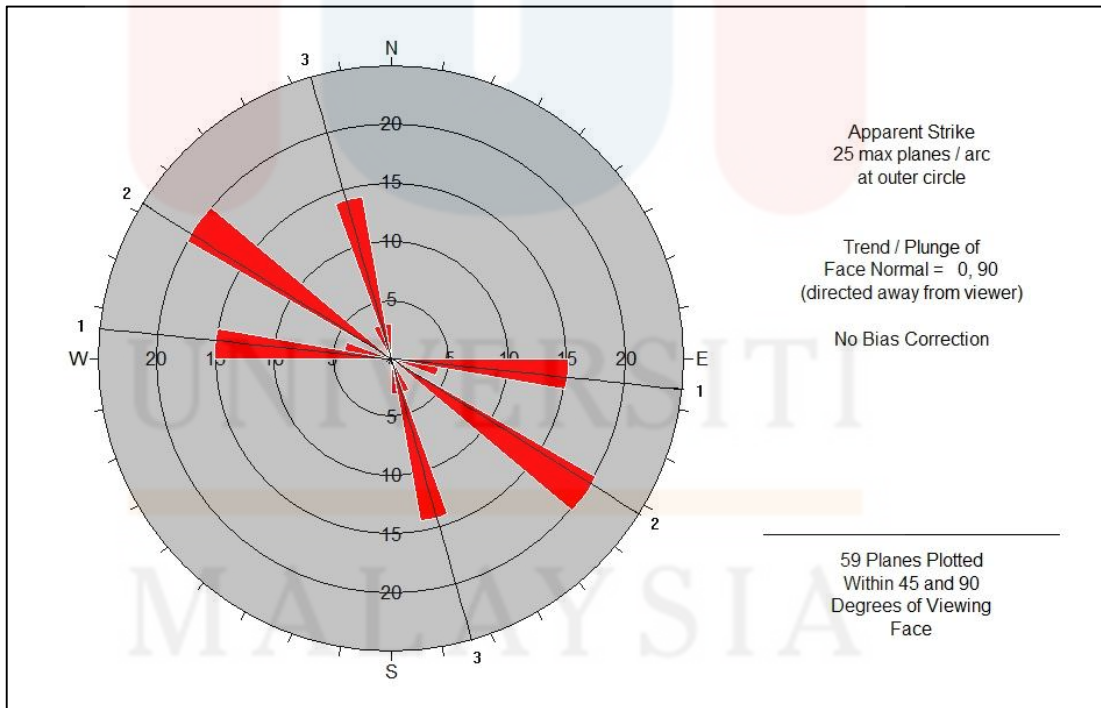
Figure 5.2.6: Rosette plot of orientation of joint on Slope 3A

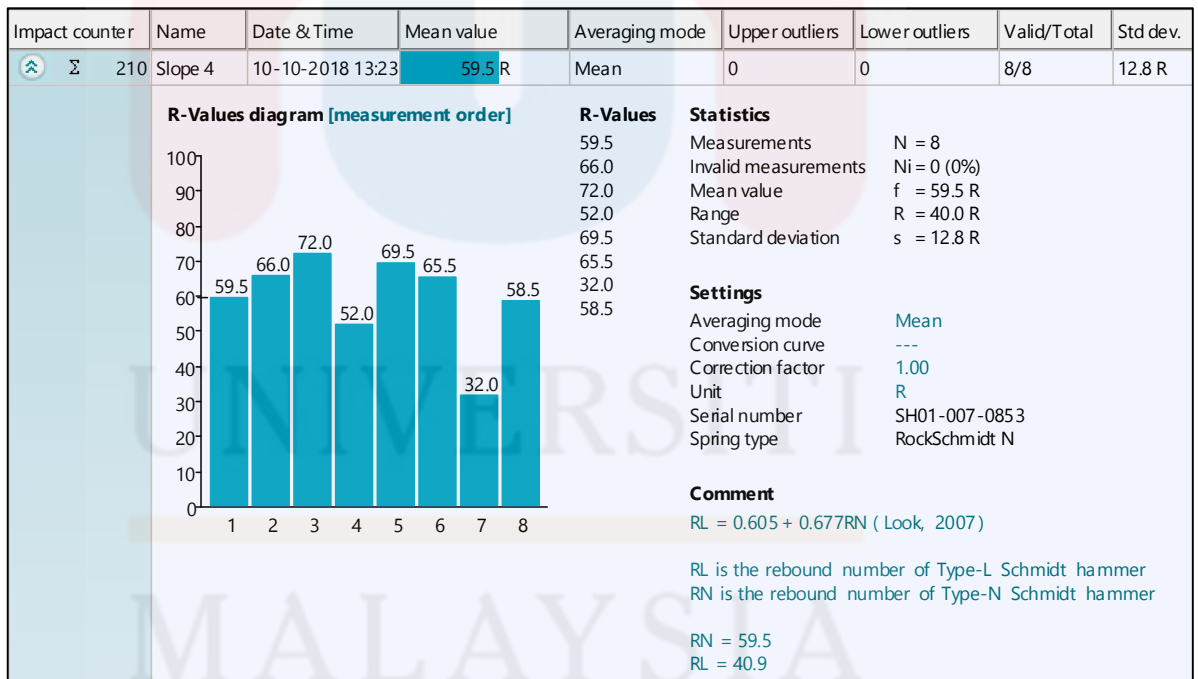
Figure 5.3.4: Chart of Type-N Schmidt hammer rebound number at Slope 4

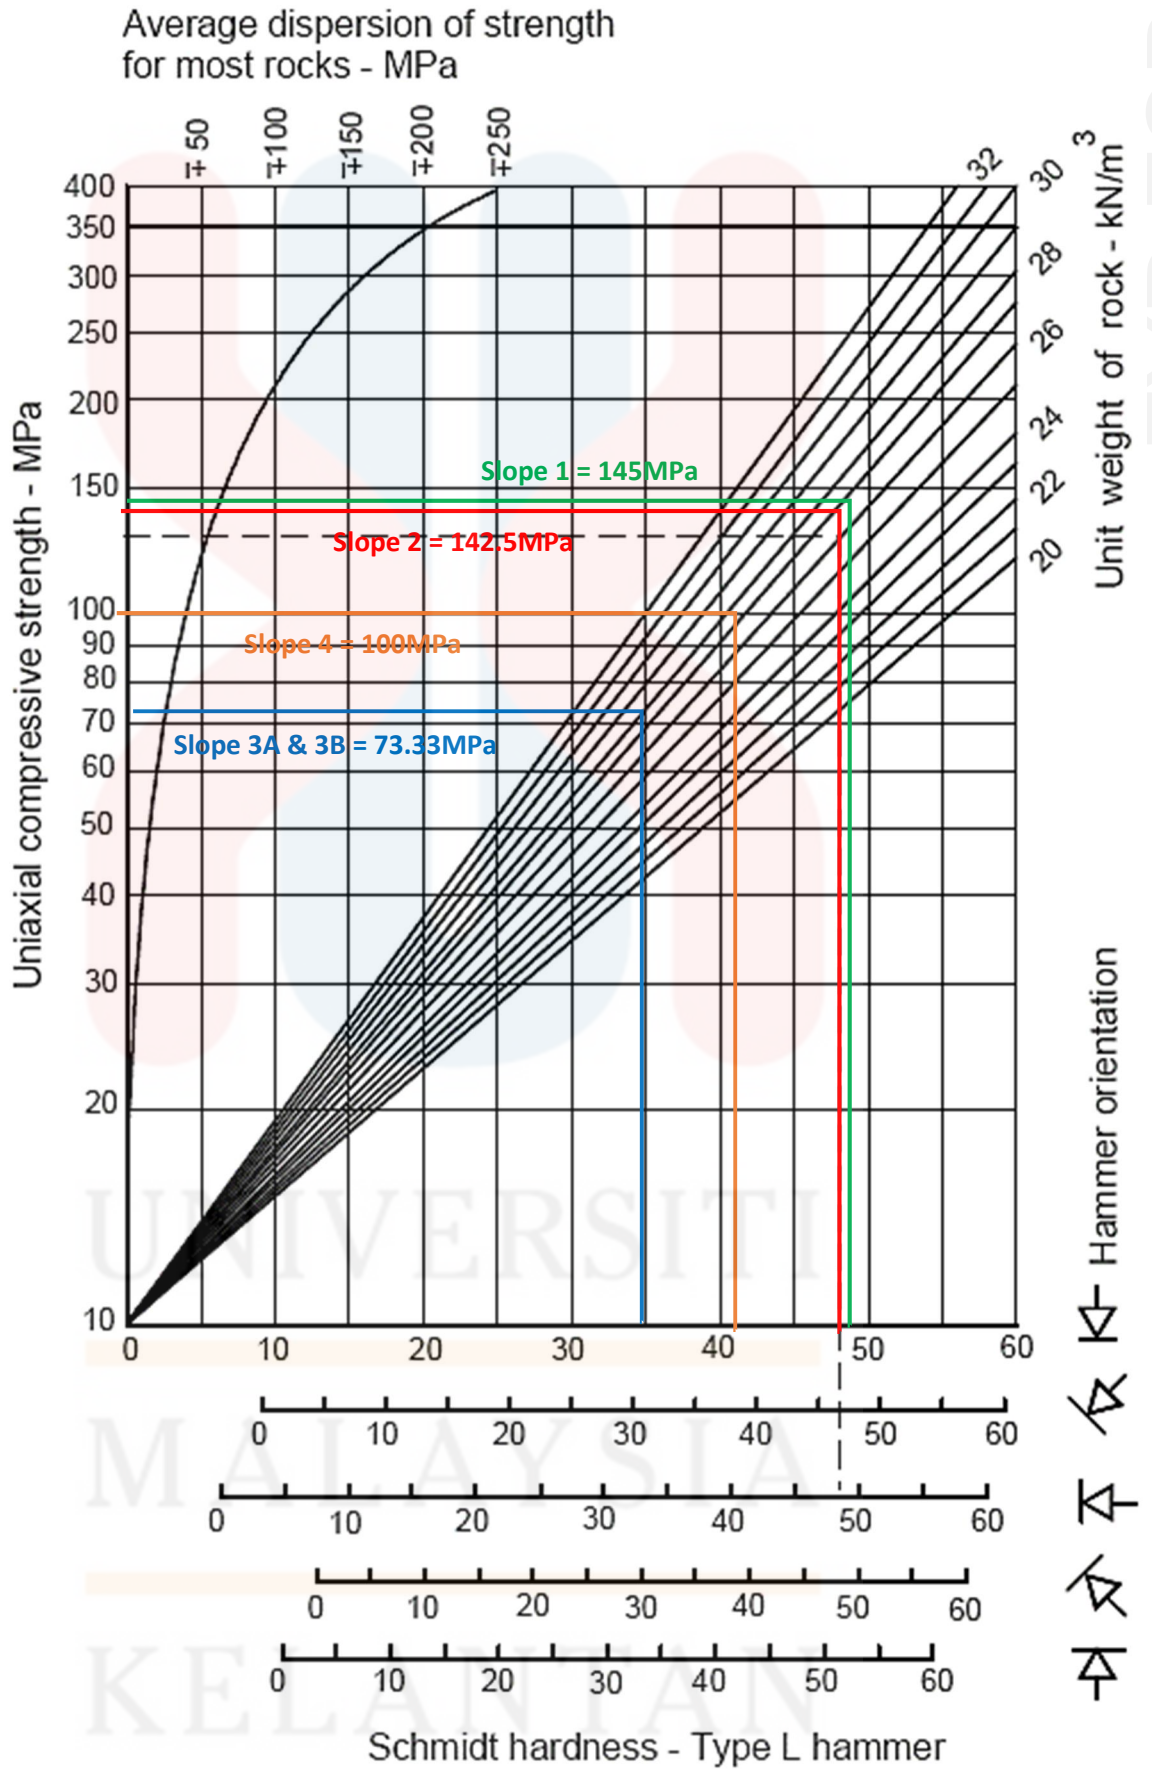
Figure 5.3.5: Correlation of rebound number,  $R_L$  with UCS value

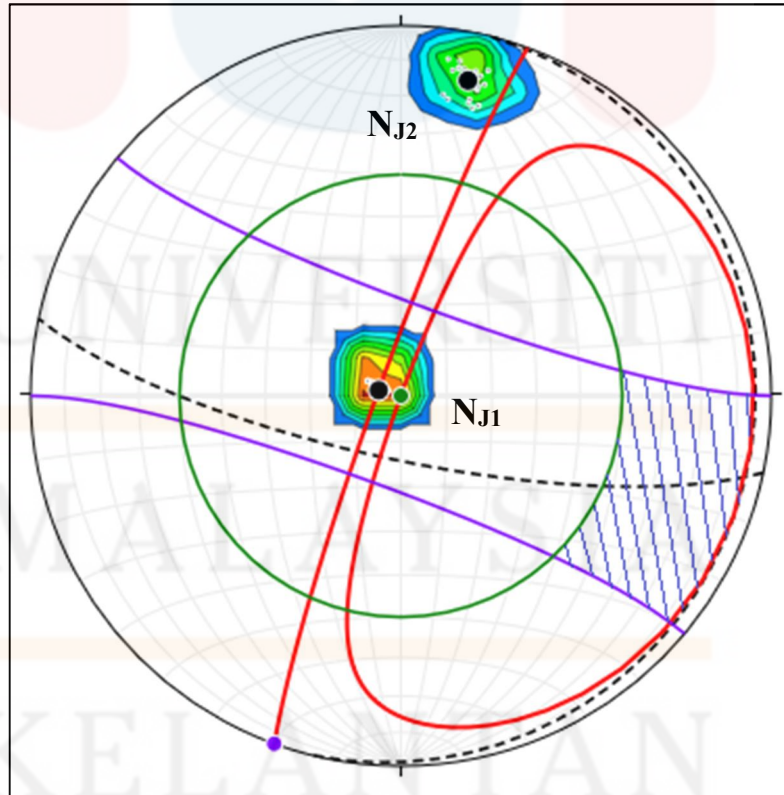
Figure 5.5.5: Kinematic Analysis of Slope 4

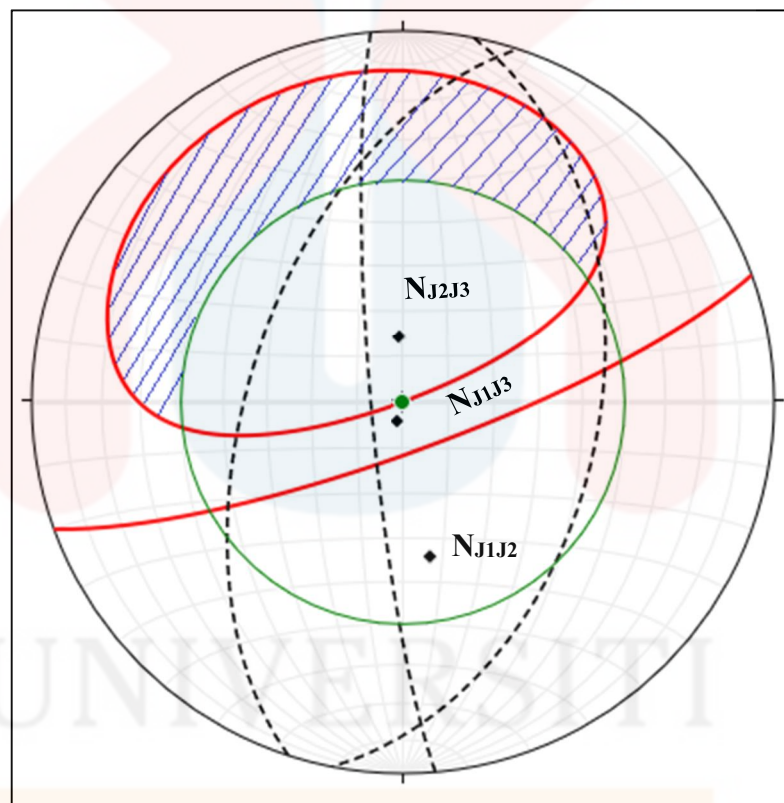
**Figure 5.5.6:** Kinematic analysis of wedge failure for Slope 1

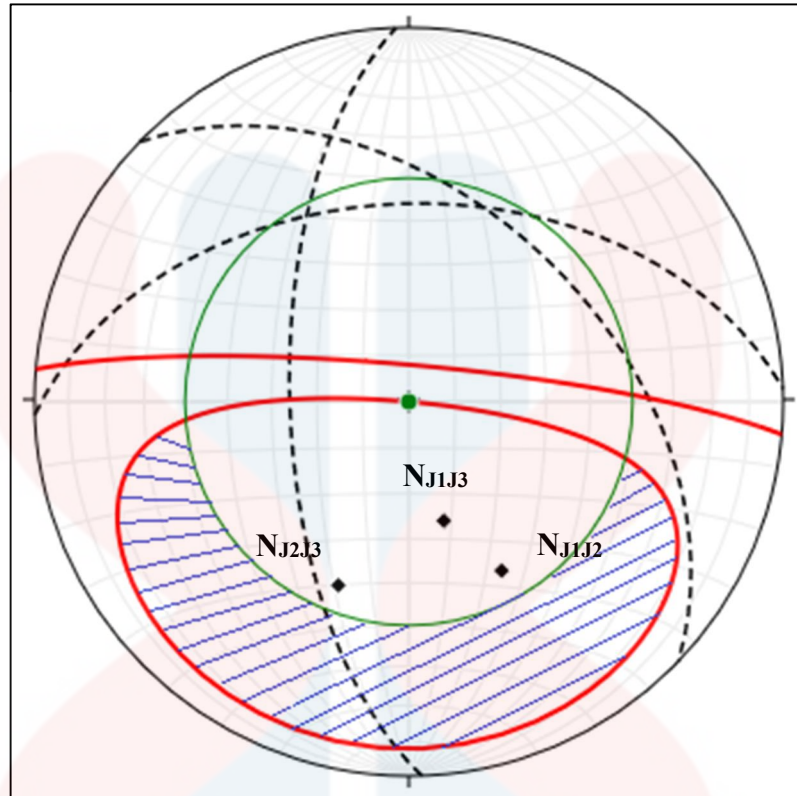
Figure 5.5.7: Kinematic analysis of wedge failure for Slope 2

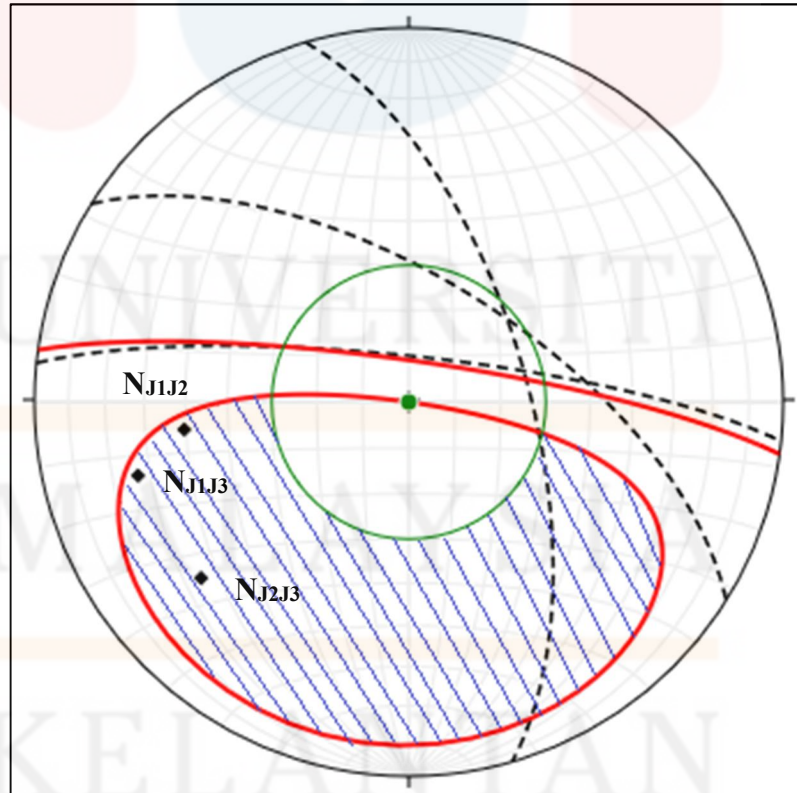
Figure 5.5.8: Kinematic analysis of wedge failure for Slope 3A

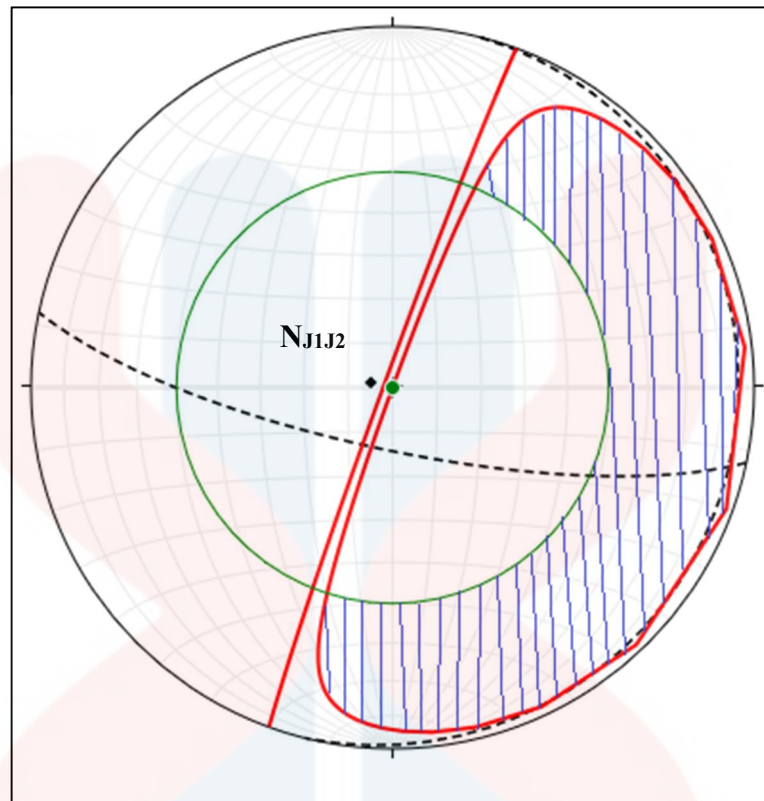
**Figure 5.5.9:** Kinematic analysis of wedge failure for Slope 4
