**GENERAL GEOLOGY AND CUT-SLOPE
STABILITY ANALYSIS OF SOIL USING
SLOPE/W AT KAMPUNG JABIR, JELI,
KELANTAN.**

A thesis submitted in fulfillment of the requirements for the degree of
Bachelor of Applied Science (Geosciences)

**FACULTY OF EARTH SCIENCE
UNIVERSITI MALAYSIA KELANTAN**

2017

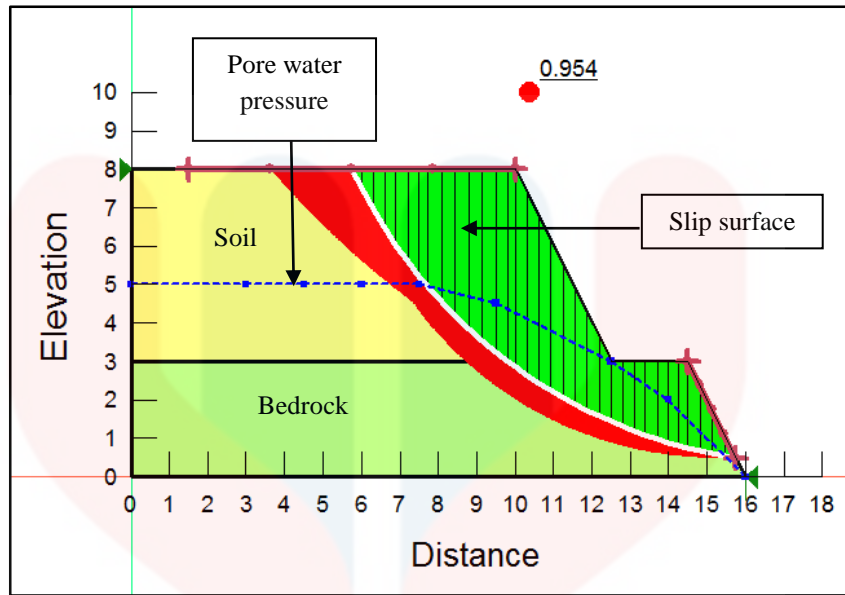
Figure 2.5 The slope stability analysis in term of factor of safety (FOS).

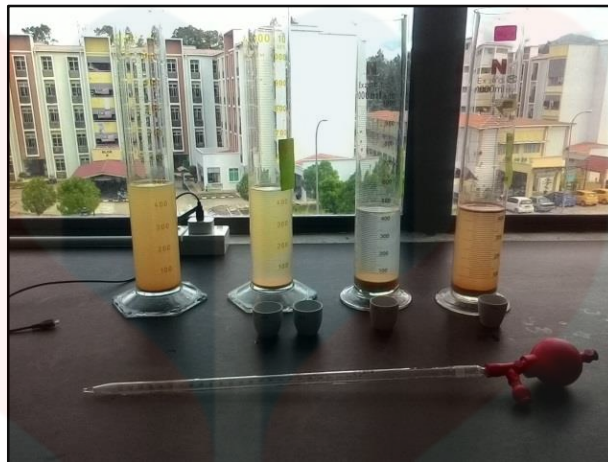
Figure 3.2 The pipette test

10 cm below the surface of the water in the cylinder. The 25 ml suspension was pipetted every three specific time interval.

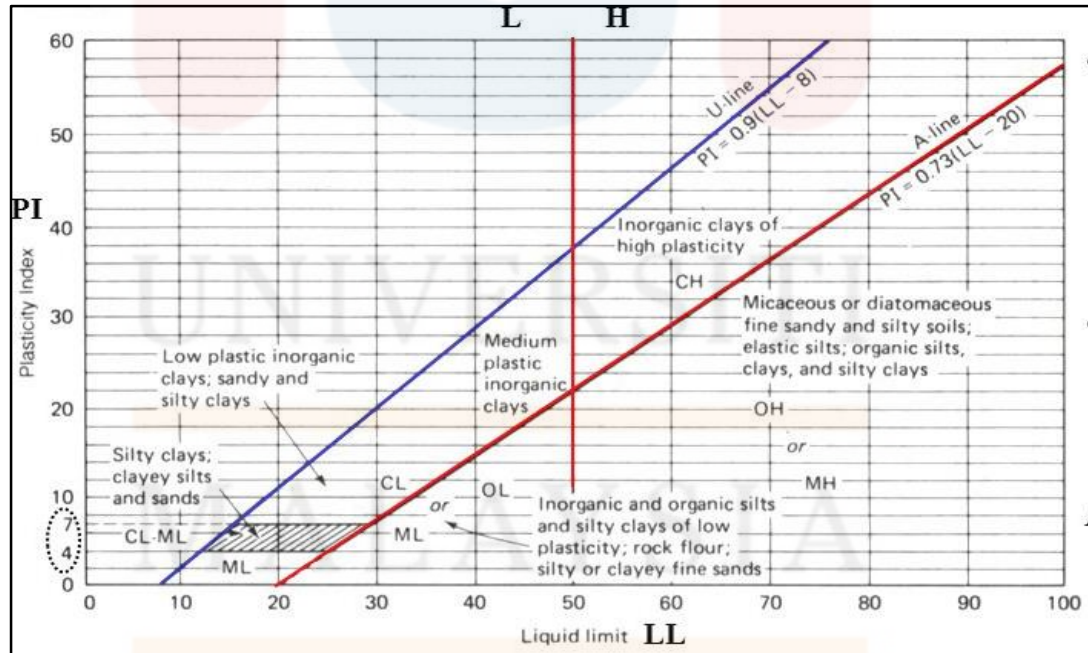
Figure 3.4 The plasticity chart (Holtz, R.D. and Kovacs, 1981)

For plasticity chart, an A-line divides the inorganic clays and the inorganic silts. Inorganic clay values lie above the A-line and values for inorganic silts lie

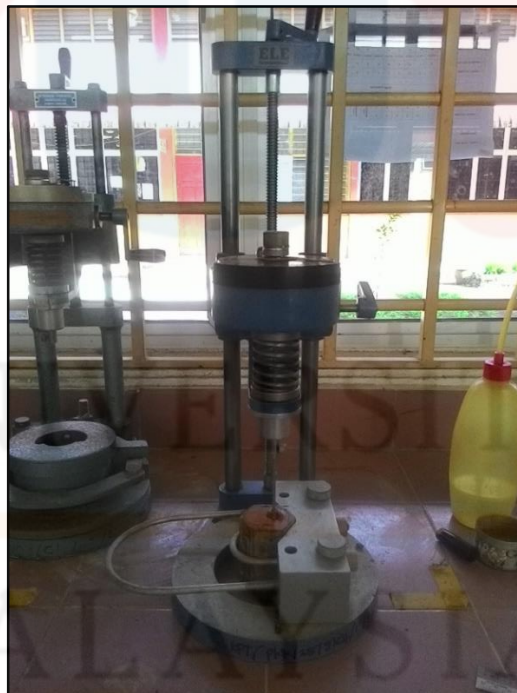
Figure 3.6 The Vane Shear Test equipment

The Vane Shear Test was used to determine the shear strength of clay soil (Figure 3.6). It is a cheaper and quicker method that has been done in laboratory. This test is done for soils that had a low shear strength (less than 0.3 kg/cm^2) which

The vanes were rotated at a uniform rate by suitable operating the torque application handle until the sample was failed. The final reading of the angle of twist was recorded.

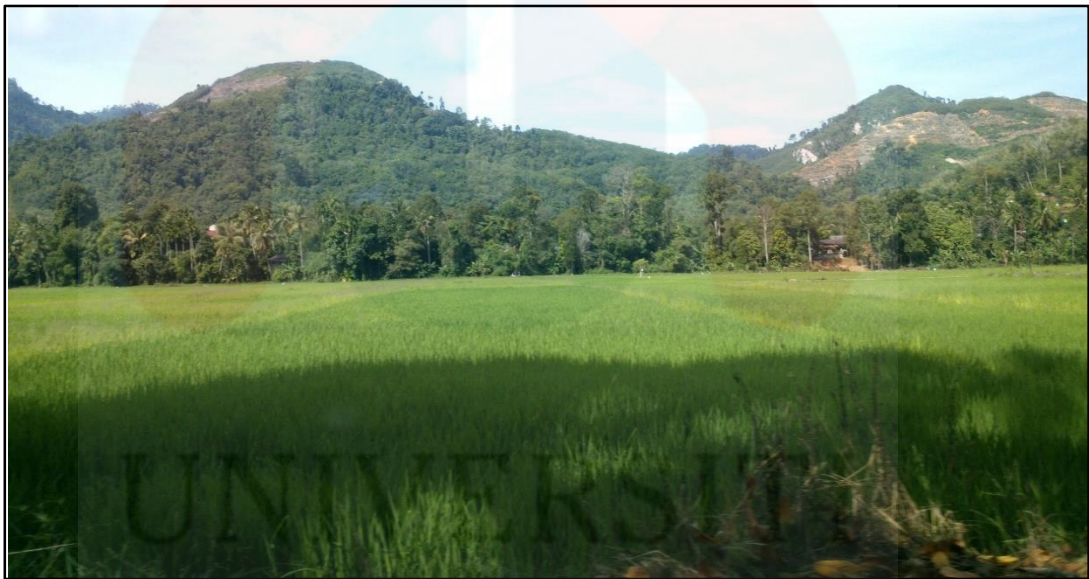
Figure 4.3 Hilly landform at Kampung Jabir

Geomorphology analysis is done at the study area. The type of rocks that found in the area are known based on contour pattern. For the study area, the mountainous area has the characteristic of igneous rock. Furthermore, the hilly area belongs to igneous rocks and metamorphic rocks (Figure 4.3). Yet, the undulating area have a sedimentary rock.

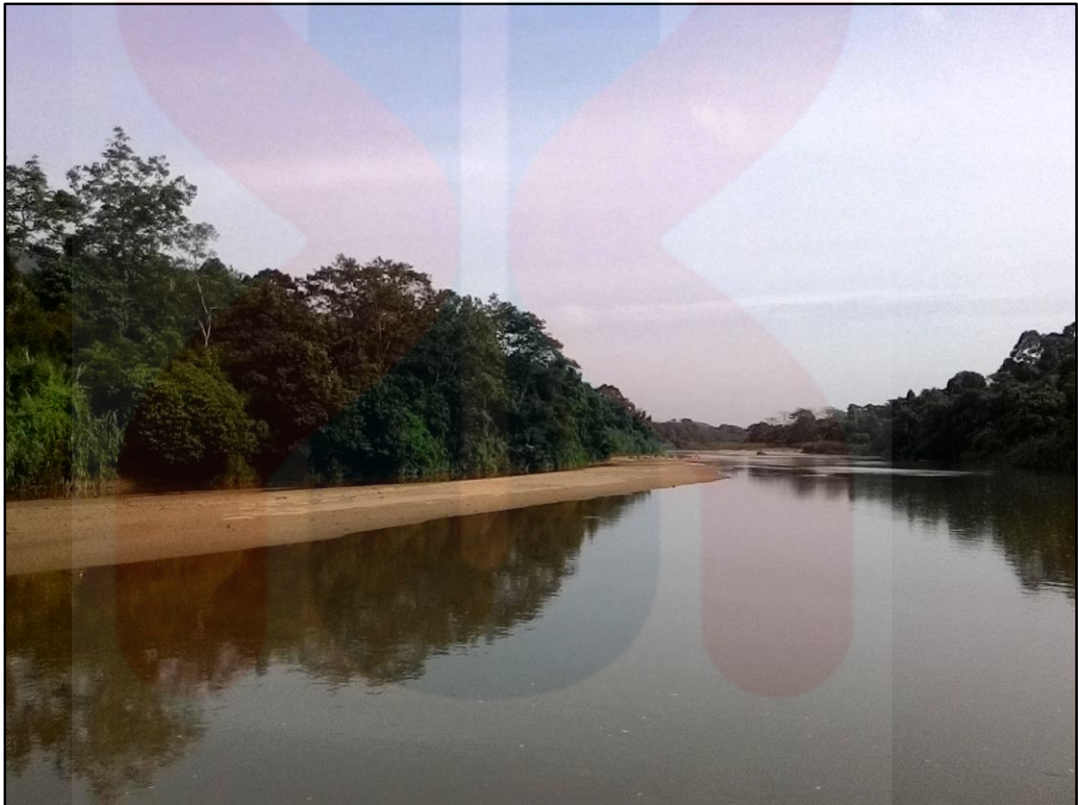
Figure 4.5 Old stage river (Pergau river)

Next, the stage of the river is essential to be known. There is a main river in study area which is Pergau River at the East part. The river indicate to be at the old stage river (Figure 4.5). This is due to the features of the river which has very low steepness in the river gradient. Besides, the river has very broad floodplain and have a lot of meanders arc. These features are abundant and prominent for older river.

Other than that, the Pergau river also has a lot of sand deposits at the center of the rivers. That means the rivers are able to transport fine sediments such as silts and clays. The channels of the rivers are broad due to the widespread side erosion and the water flow is fairly slow.

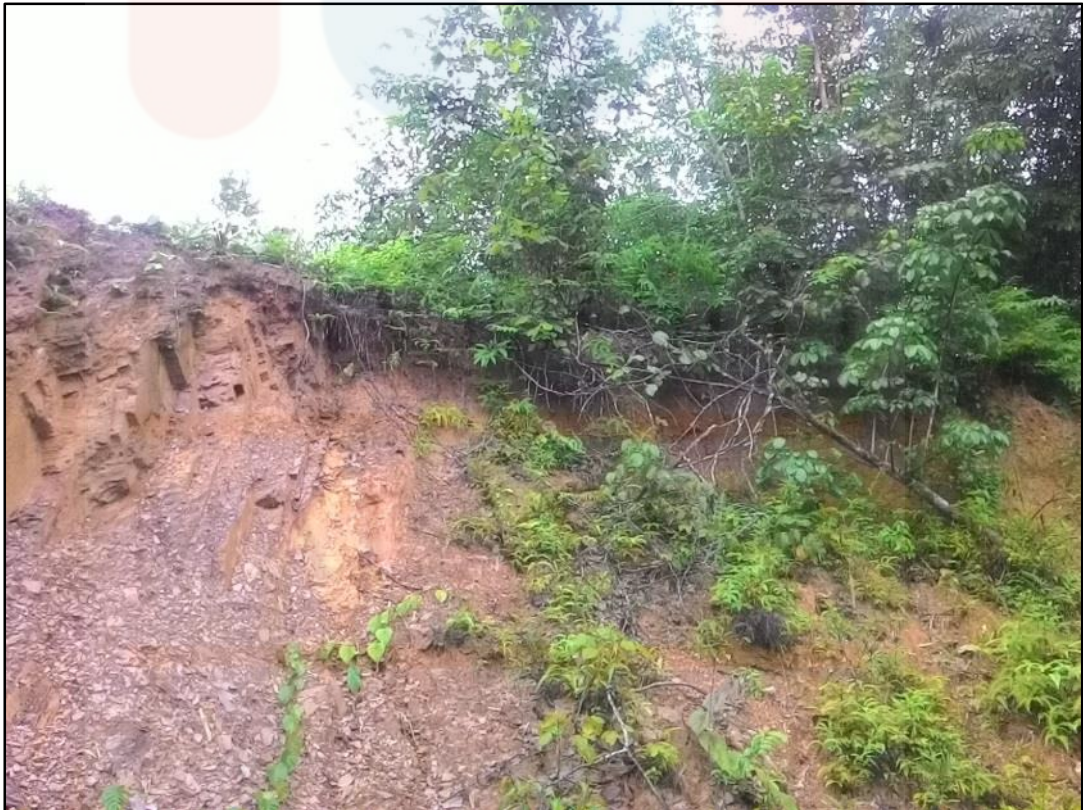
Figure 4.7 Biological weathering in the study area

For biological weathering, the rock is disintegrates because of the biological activity of plants, animal and microbes. The biological weathering at N 05°31' 18", E 101° 53' 21.3" can be seen on the shale that covered by vegetation and become lose. The biological weathering might take place as growing plant roots that give the stress or pressure on the rock (Figure 4.7).

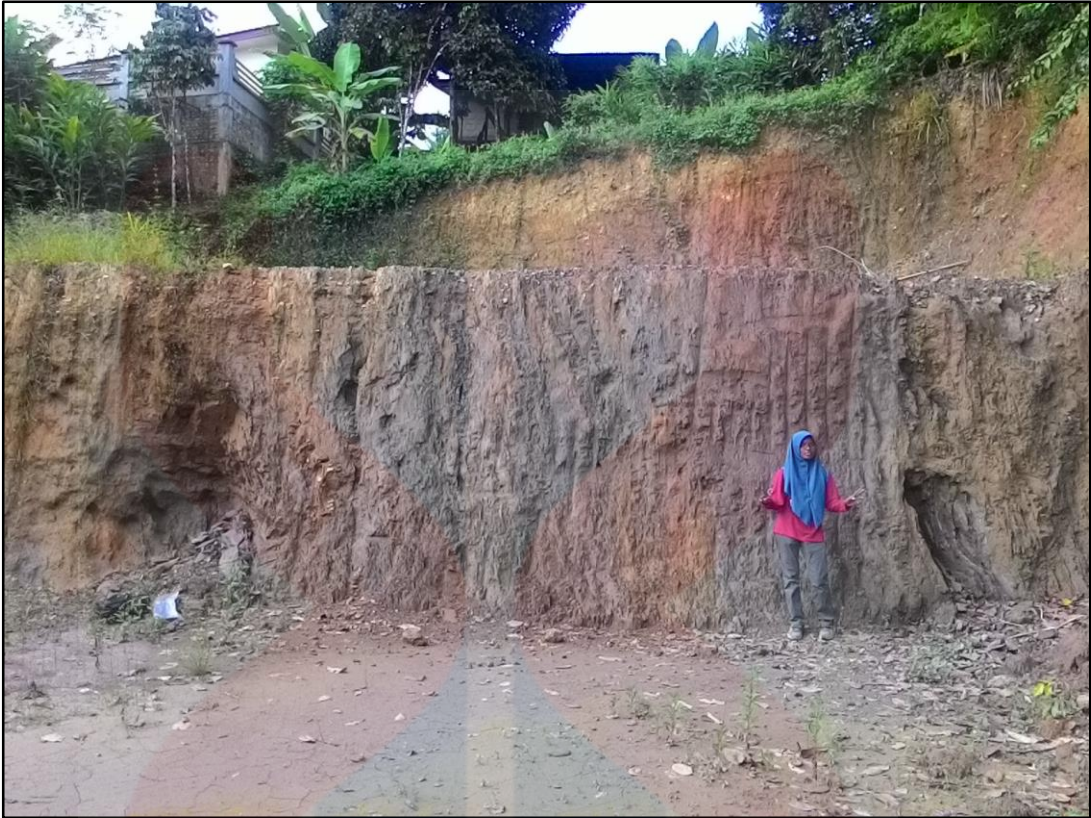
Figure 4.8 Outcrop of shale at Station 8

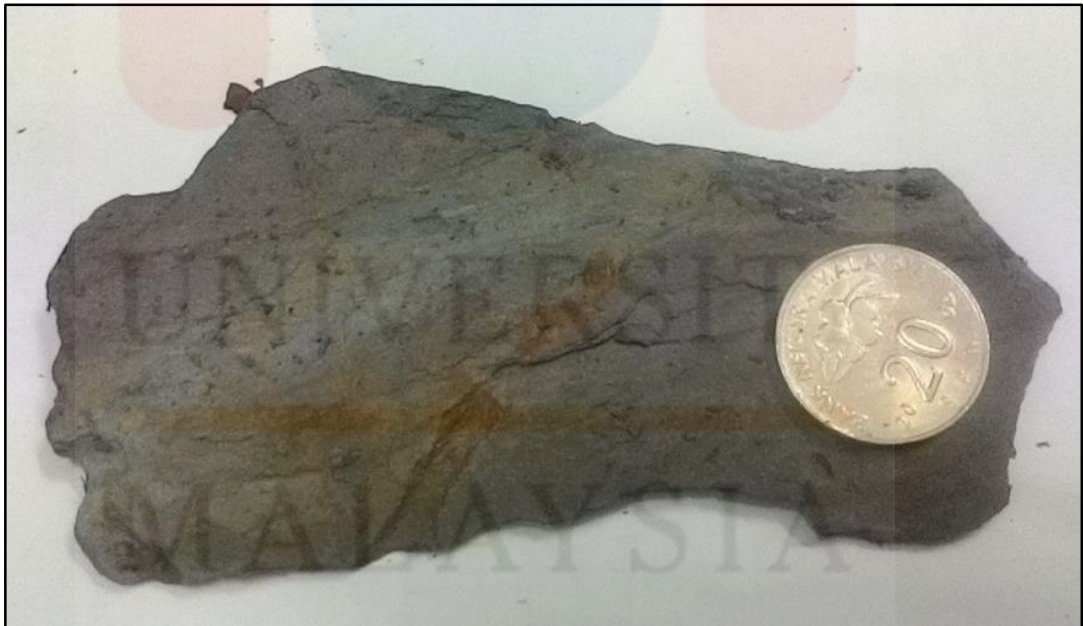
Figure 4.9 Hand specimen of Shale

For hand specimen, the colour of rock is grey colour. This rock is very fine-grained. The texture of shale is smooth. This rock also fissile and laminated. No fossil present. Shale does not react with HCL (Figure 4.9).

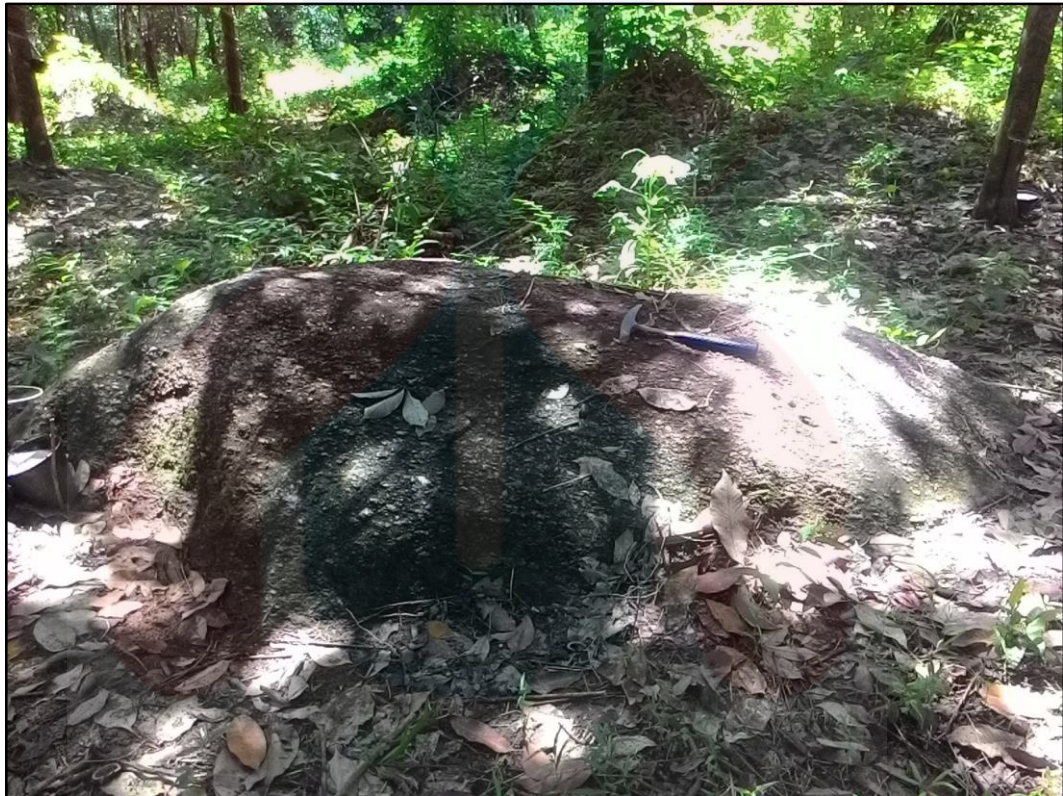
Figure 4.10 Outcrop of granite at Station 2

The outcrop is situated at N 05°32' 46.2", E 101° 53' 00.2" which is at the west of study area. The height of outcrop is 0.5 m and the width of the outcrop is 3 m (Figure 4.10). The outcrop is found in the rubber estate and foothill. Some part of the outcrop is weathered.

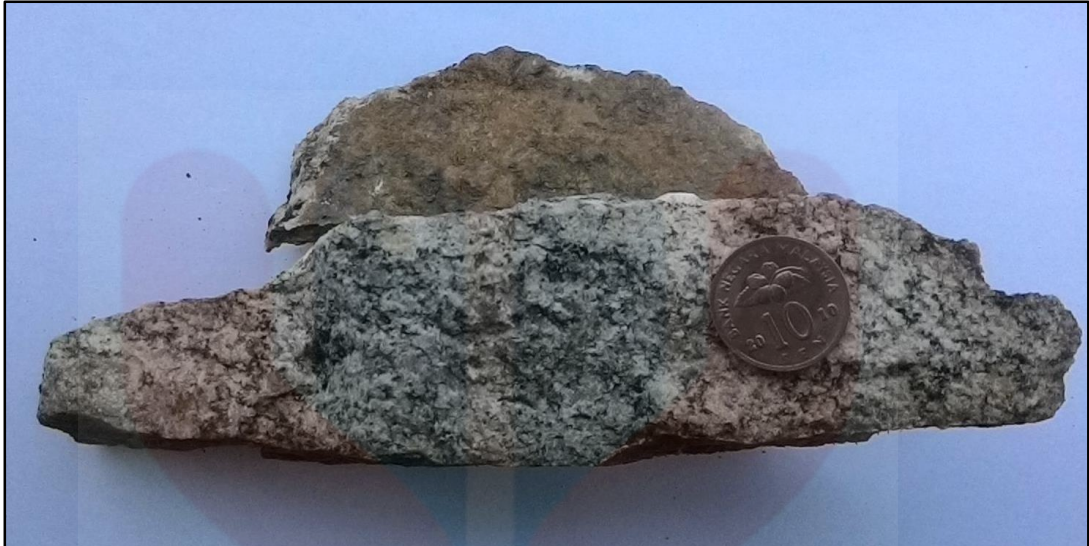
Figure 4.11 Hand specimen of granite

Based on hand specimen shown in Figure 4.11, the color of rock is white because it is intrusive igneous rock. The rock is a coarse-grained that can be seen by the naked eyes. This rock also very hard and crystalline. The texture of the rock is rough (Figure 4.11).

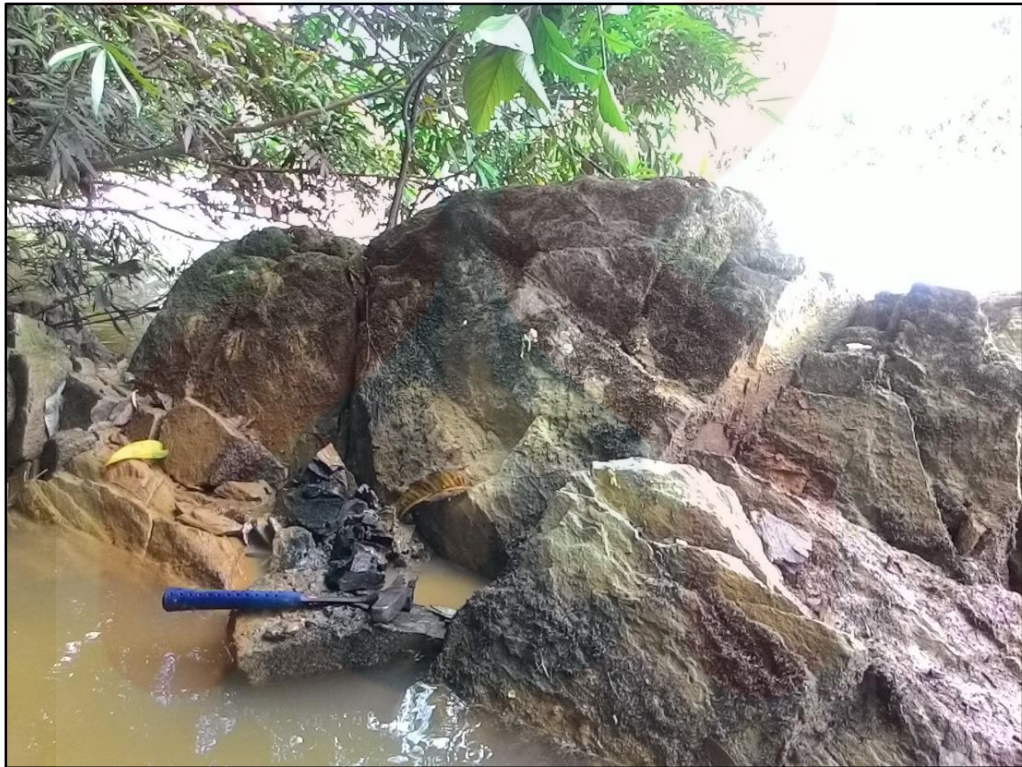
Figure 4.13 Outcrop of granite at Station 4

The outcrop is located at N 05°32' 38.9", E 101° 53' 33.8" which is at east of the study area. The height of outcrop is 1.5 m and the width of the outcrop is 3 m. The outcrop is on the Pergau river (Figure 4.13). The outcrop is fresh and some part of the outcrop is weathered. The outcrop also covered by moss.

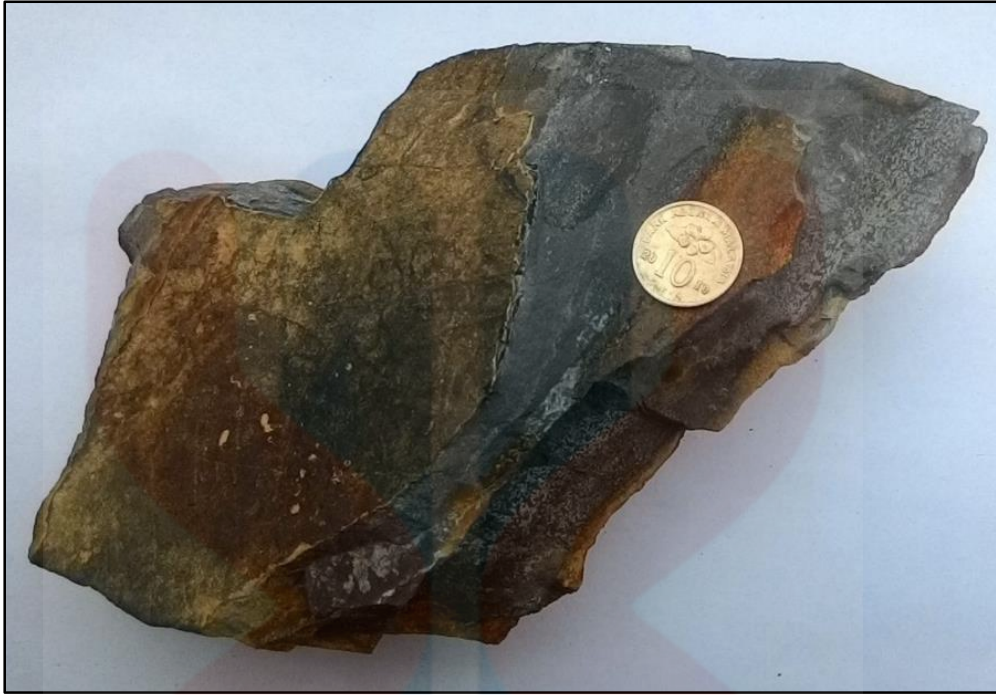
Figure 4.14 Hand specimen of Slate

For hand specimen, the color of rock is grey. The rock is a fine-grained that cannot be seen by the naked eyes. This rock also hard and dull. The texture of the rock is smooth (Figure 4.14). This rock have a foliation.

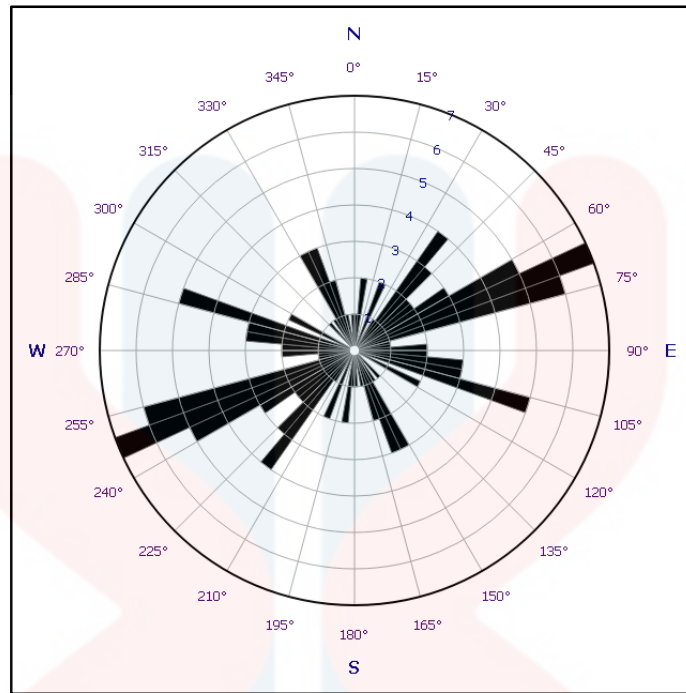
Figure 4.18 Rose diagram for lineament

Based on the Figure 4.18, the major orientation of the lineament was in NNE-SSW direction. Minor orientation of the lineament was in SSE-NNW.

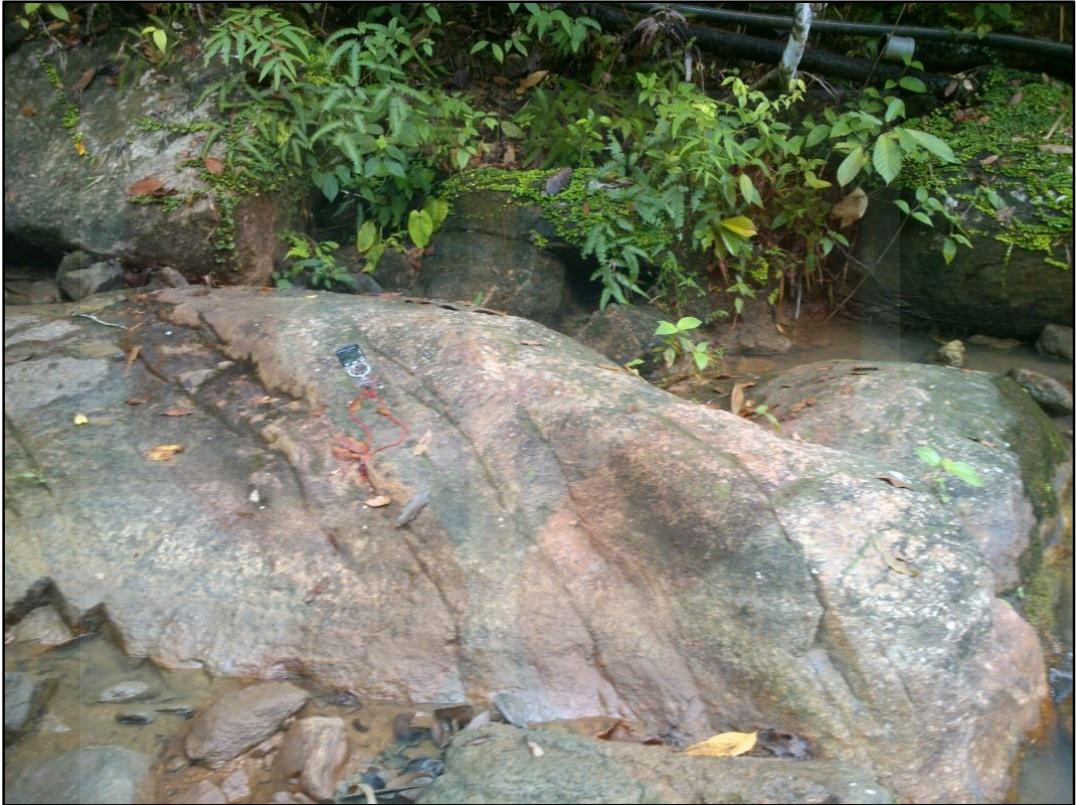
Figure 4.19 The joint set at Station 10

Joint analysis was done to identify the direction of forces acting based on fracture on rocks. Joint analysis also was prepared by taking 100 readings of strike on the surface of granite found at N 05°30' 42.7", E 101° 52' 46.6". This rock is situated in the stream which is SSW part of the study area. Figure 4.19 shows the joint set. The joints that are found are extension joint with the length ranges from 2.0 m to 3.0 m. Figure 4.20 shows the rose diagram of joint analysis which has major direction of force was NNE-SSW. Minor direction of force was SSE-NNW.

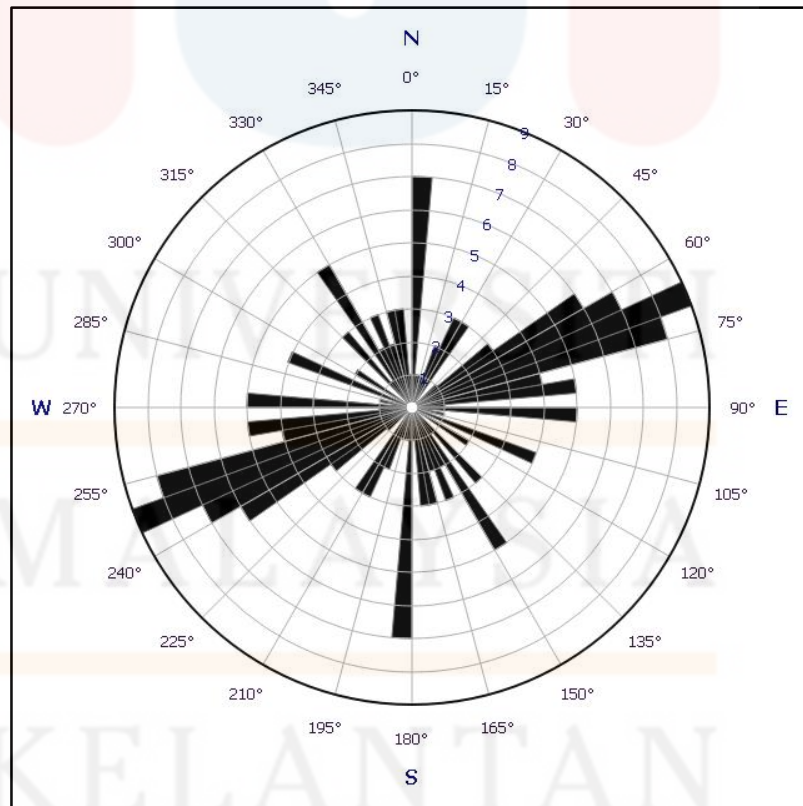
Figure 4.20 The rose diagram of joint analysis at Station 10

The major orientation of the joints that are found at granite was NNE-SSW direction. The lineament interpretation data was used as a correlation with the joints. The rose diagram of lineament analysis also shown the major direction of force was NNE-SSW. The orientation of joints that found at the study area was in similar direction as the orientation of lineament. Then, the direction of the force that acted upon during the joint formation can be concluded that was similar to the lineament which is NNE-SSW direction.

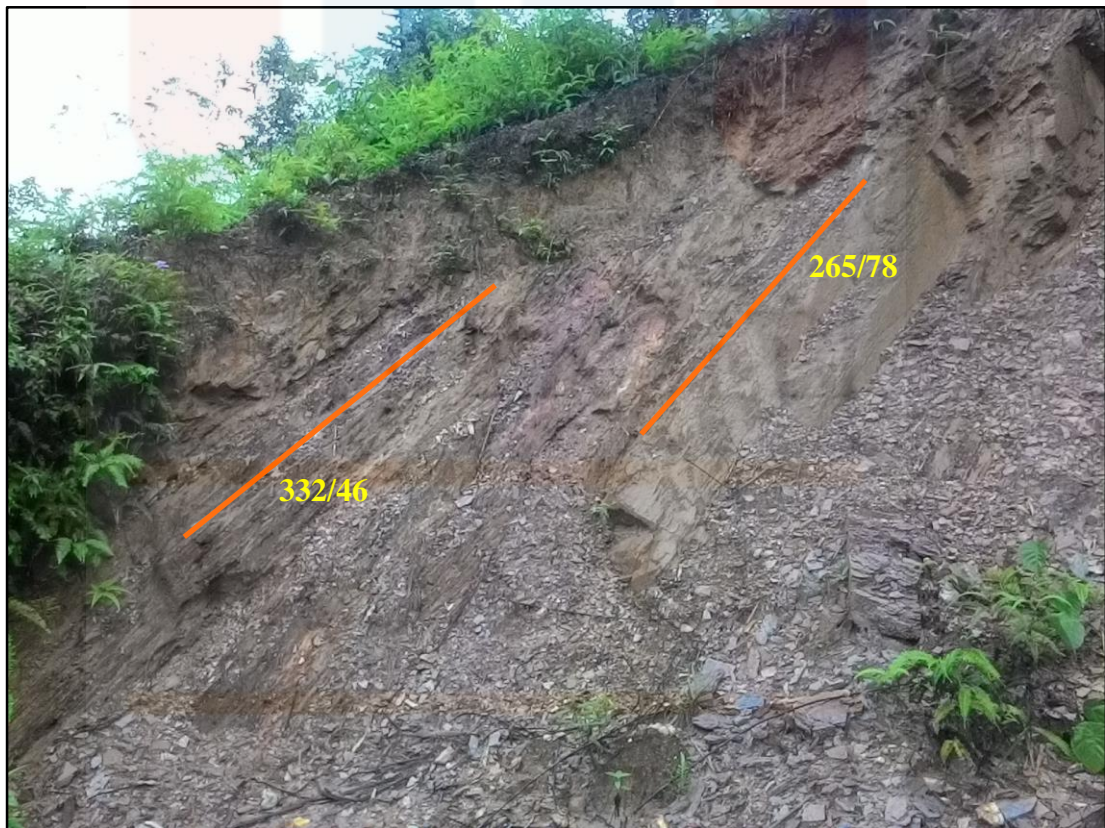
Figure 4.21 Bedding found at the Station 6

Bedding was found at N 05°31' 18", E 101° 53' 21.3". Bedding is layering at shale outcrop close to the road. The bedding directions is shown in Figure 4.21.

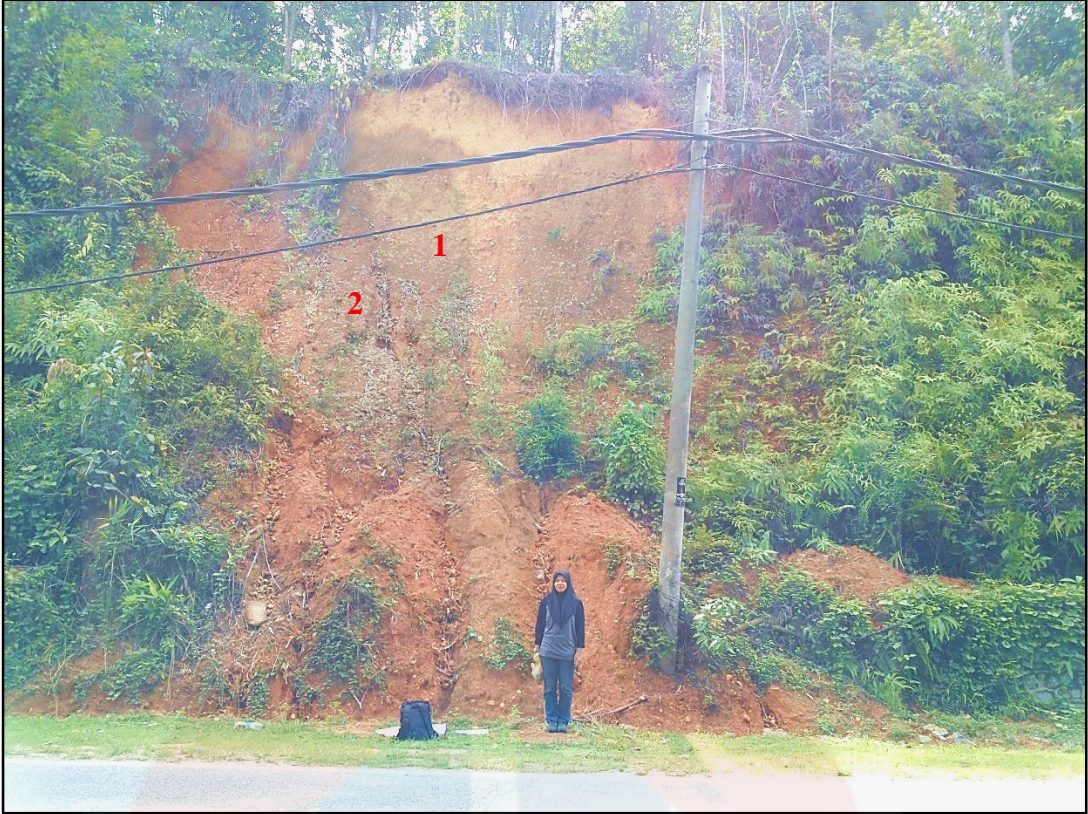
Figure 5.2 Slope failure at location 1

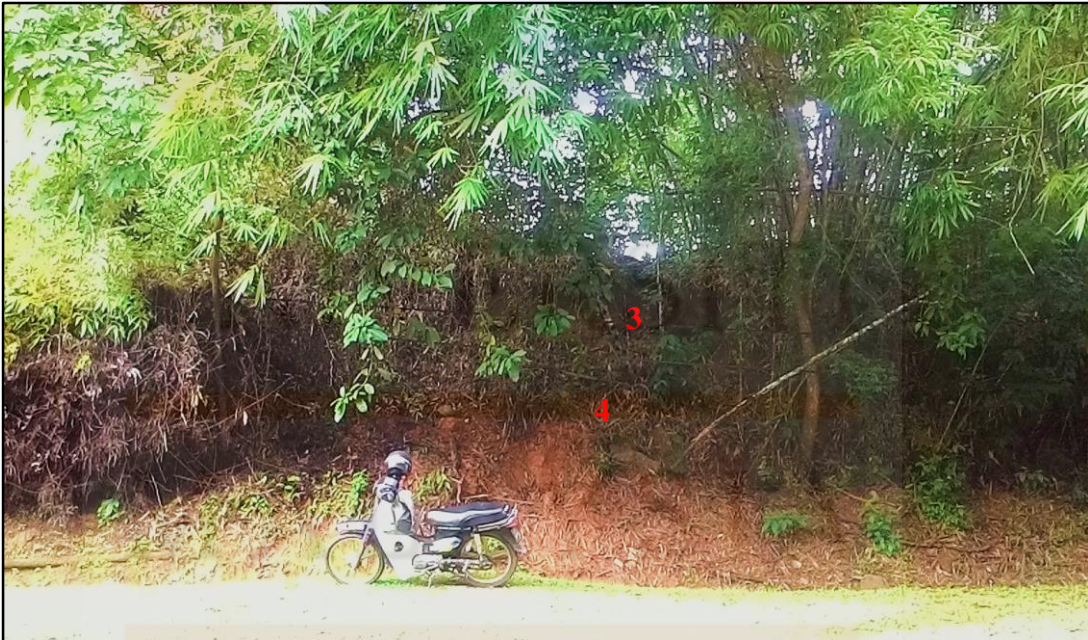
Figure 5.3 Slope failure at location 2

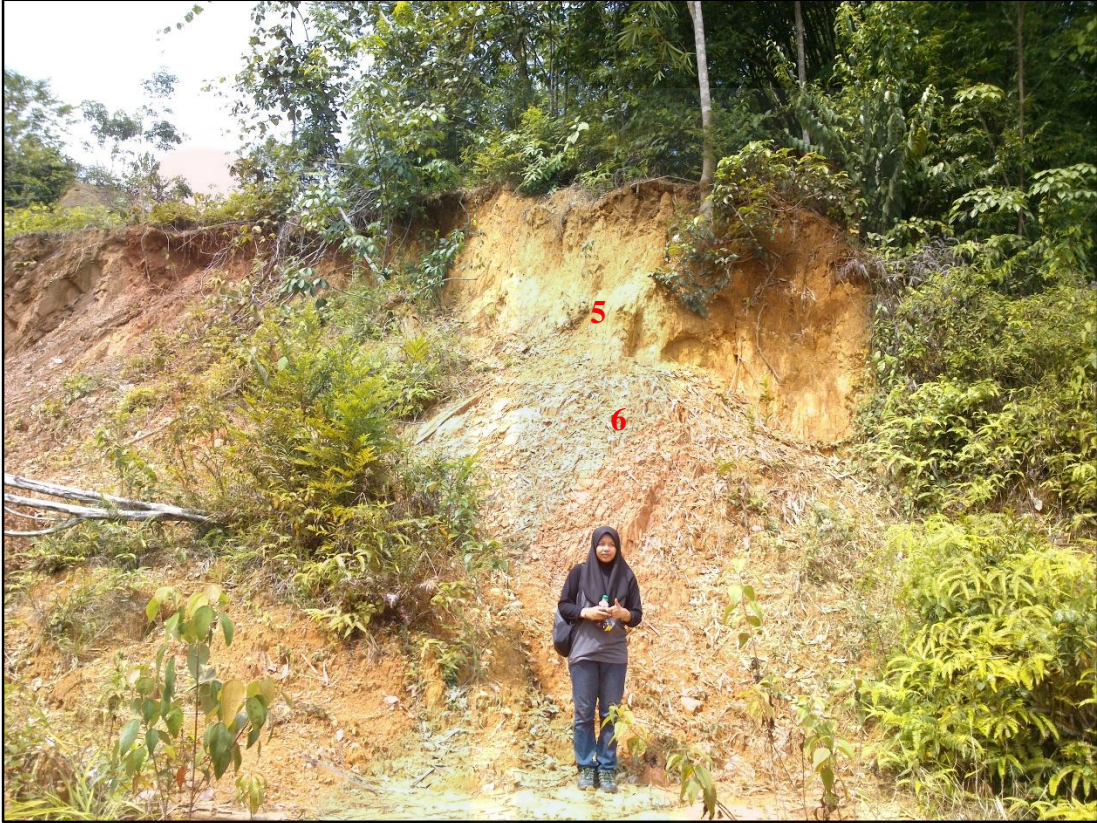
Figure 5.4 Slope failure at location 3

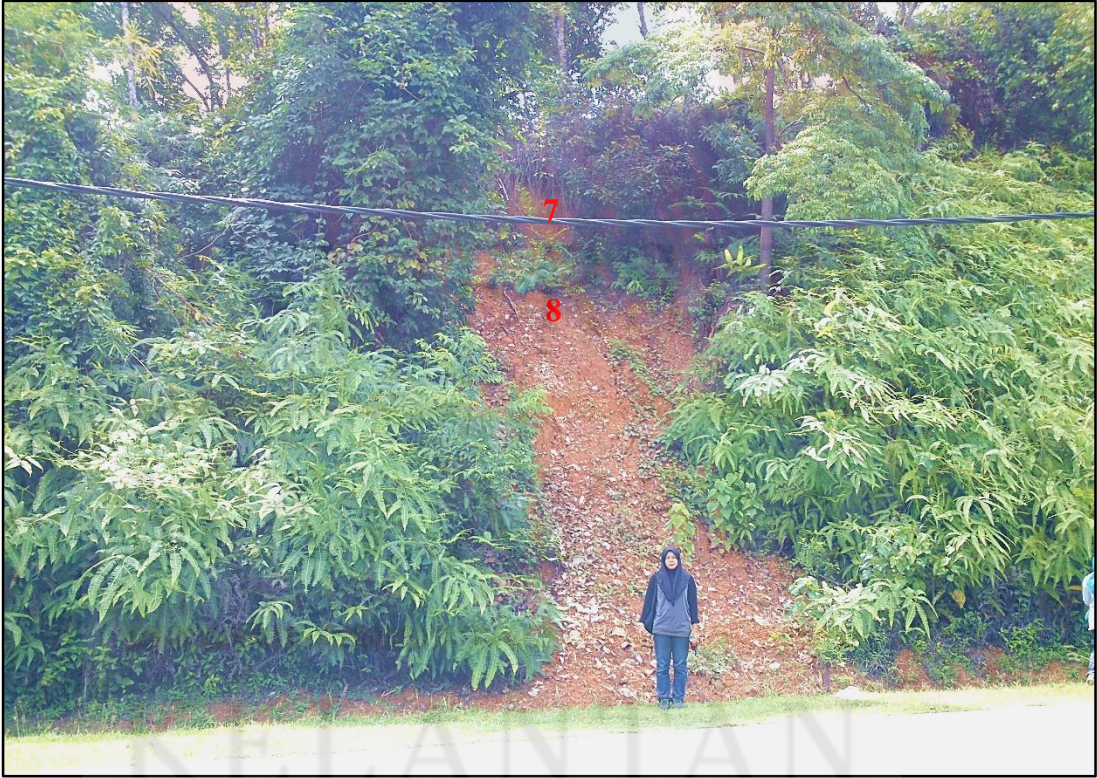
Figure 5.5 Slope failure at location 4

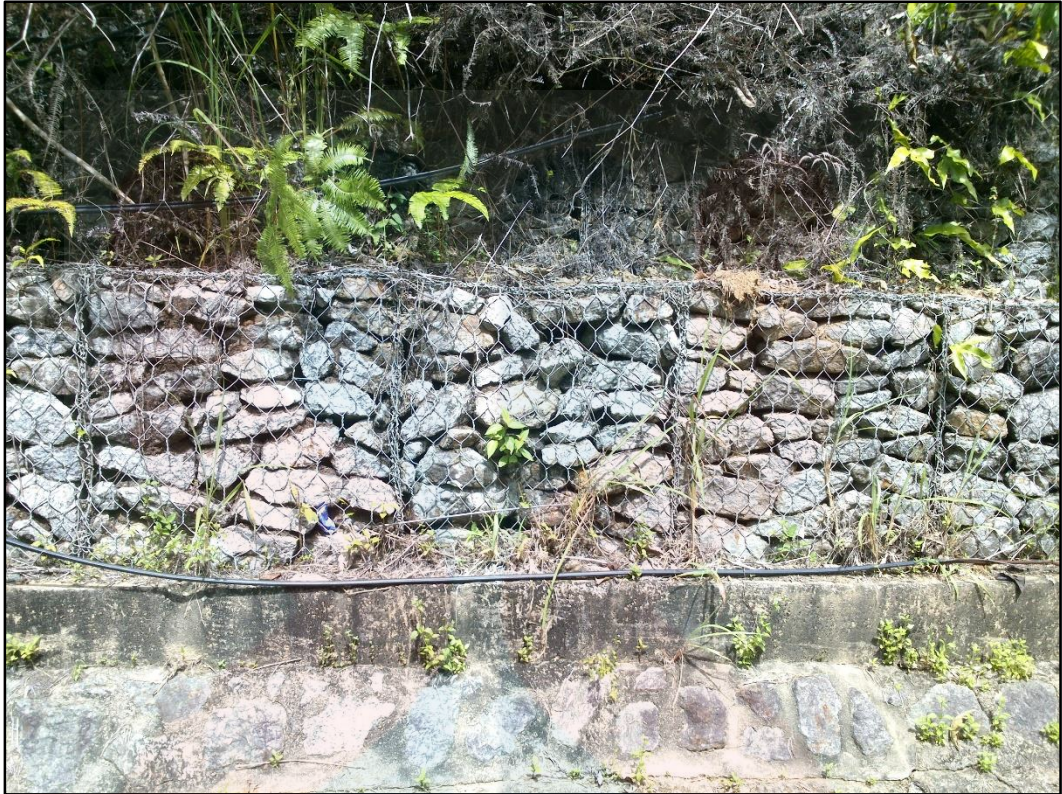
Figure 5.6 Gabion wall at location 3

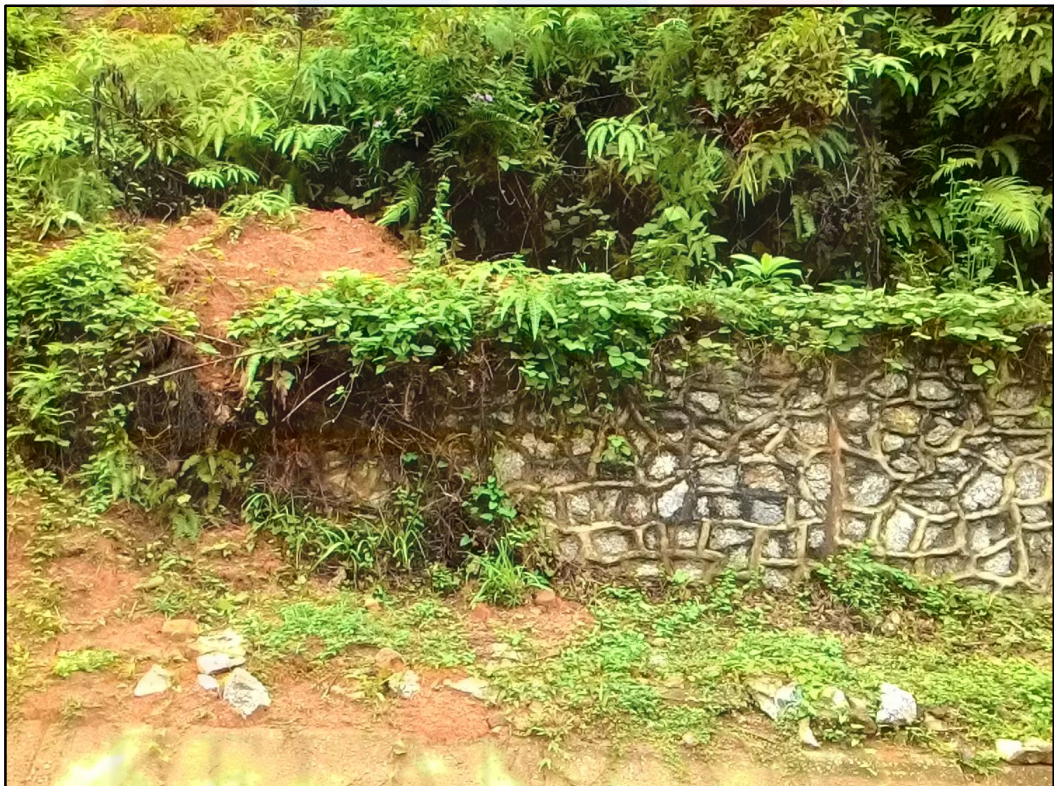
Figure 5.7 Stone pitching at location 1

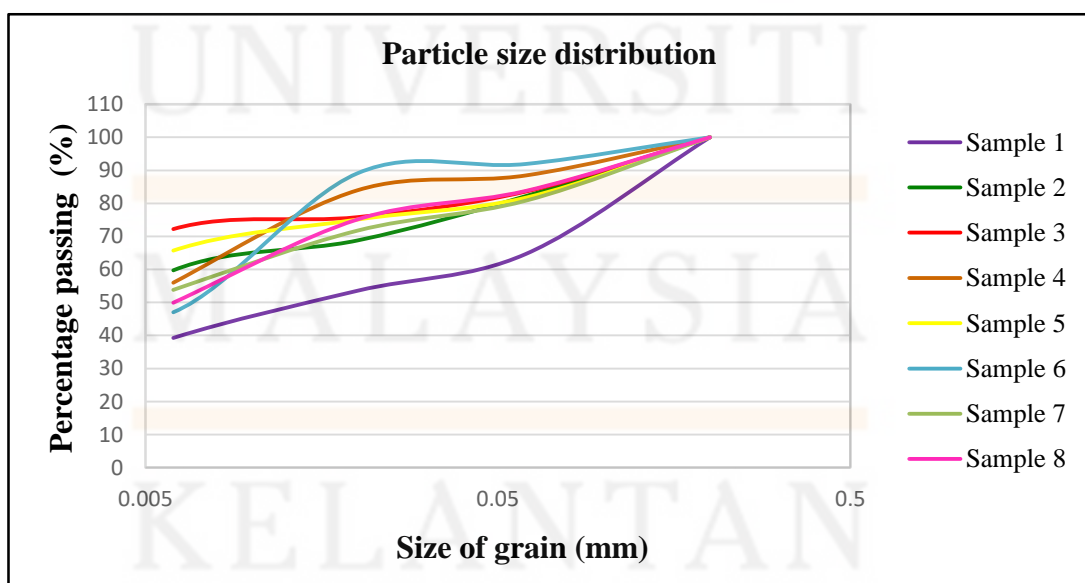
Figure 5.12 The graph of the percentage passing against particle size of all samples

Sedimentation test is done for grain size analysis using the pipette method. The particle size of eight soil samples from four location is classified and shown in Table 5.4. Sedimentation test only can be used for fine-grained such as fine sand, silt, and clay. The graph the percentage passing against particle size of all samples have been shown in Figure 5.12. The result show that, the sample 1, 2, 4, 5, 6, 7 and 8 have more silt. The sample 3 have more clay.
